# Access Compliance Report

## Public Rights-of-Way

### (Curb Ramps)

Intersection ID: 5808	Main Street: FOREST_POND_DR	Cross Street: NEVIN_RD	Location: SW
ADA ID: 498B6ADD0002	Ramp Type: Perp	Initial Pass/Fail: Fail	Overall Compliance: No
		Severity Score: 25

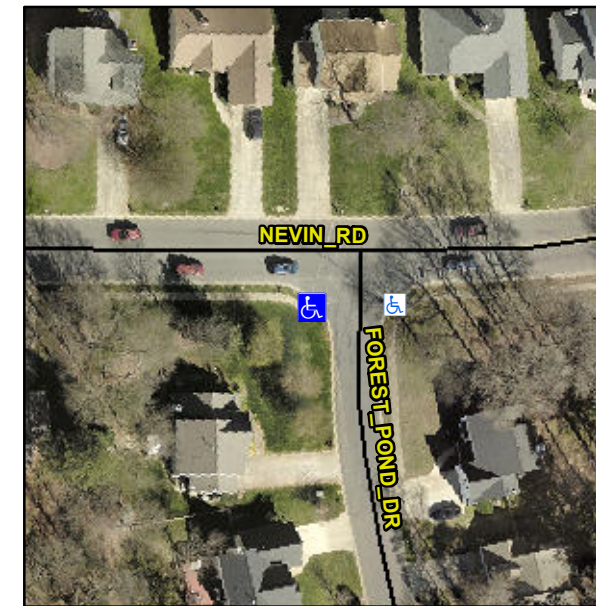
**Not Found, R304.5.3**

Compliance	Description	Data	Compliance	Description	Data
N/A	Ramp Length (in)	99.0	Yes	Ramp Slope (%)	6.7
Yes	Ramp Width (in)	48.0	No	Ramp XSlope (%)	7.7
N/A	Flare Type LT	N/A	N/A	Flare Type RT	N/A
N/A	Flare Slope LT (%)	N/A	N/A	Flare Slope RT (%)	N/A
N/A	Flare Traversable LT?	N/A	N/A	Flare Traversable RT?	N/A
N/A	Landing Length (in)	N/A	N/A	DWS Provided?	N/A
N/A	Landing Width (in)	N/A	N/A	DWS Contrast?	N/A
N/A	Landing Slope (%)	N/A	N/A	DWS Length (in)	N/A
N/A	Landing X Slope (%)	N/A	N/A	DWS Full Width?	N/A
N/A	Landing Curb? (Y/N)	N/A	N/A	DWS Offset (in)	N/A
N/A	Shared Landing?	N/A			
N/A	Gutter Ponding?	N/A	N/A	Gutter Slope (%)	N/A
N/A	Gutter Lip Ht (in)	2.0	N/A	Gutter X Slope (%)	N/A
N/A	Painted X Walk1?	No	N/A	Painted X Walk2?	N/A
	X Walk 1 Direction	To E		X Walk 2 Direction	N/A
N/A	X Walk 1 Width (in)	N/A	N/A	X Walk 2 Width (in)	N/A
	X Walk 1 Slope (%)	2.5		X Walk 2 Slope (%)	N/A
	X Walk 1 X Slope (%)	4.4		X Walk 2 X Slope (%)	N/A

N/A	Ramp inside XWalk1?	N/A	N/A	Ramp inside XWalk2?	N/A
	Road Slope (%)	N/A	N/A	Clear Space?	N/A
	Road X Slope (%)	N/A	N/A	Clear Space to XWalk (in)	N/A
N/A	Any Obstructions?	N/A	N/A	Storm Grate/Utility Hazard?	N/A
	Obstruction Type			Storm Grate/Utility Type	
		N/A			N/A
		Yes		Surface Condition? (G/P)	Good

**Remove & Replace Entire Ramp.**

Total Cost: \$ 1850.00
