# Access Compliance Report

## Public Rights-of-Way

### (Curb Ramps)

Intersection ID: 10031996	Main Street: MONROE_RD	Cross Street: N/A	Location: NE
ADA ID: 498BB97C1CD5	Ramp Type: PerpDiag	Initial Pass/Fail: Fail	Overall Compliance: No
		Severity Score: 25

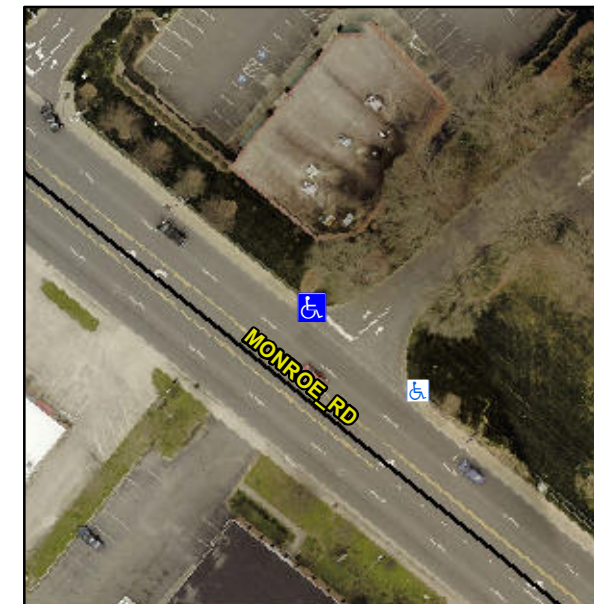
Compliance	Description	Data	Compliance	Description	Data
N/A	Ramp Length (in)	31.0	No	Ramp Slope (%)	12.1
Yes	Ramp Width (in)	48.0	Yes	Ramp XSlope (%)	0.2
N/A	Flare Type LT	N/A	N/A	Flare Type RT	N/A
N/A	Flare Slope LT (%)	N/A	N/A	Flare Slope RT (%)	N/A
N/A	Flare Traversable LT?	N/A	N/A	Flare Traversable RT?	N/A
N/A	Landing Length (in)	N/A	N/A	DWS Provided?	N/A
N/A	Landing Width (in)	N/A	N/A	DWS Contrast?	N/A
N/A	Landing Slope (%)	N/A	N/A	DWS Length (in)	N/A
N/A	Landing X Slope (%)	N/A	N/A	DWS Full Width?	N/A
N/A	Landing Curb? (Y/N)	N/A	N/A	DWS Offset (in)	N/A
N/A	Shared Landing?	N/A			
N/A	Gutter Ponding?	N/A	N/A	Gutter Slope (%)	N/A
N/A	Gutter Lip Ht (in)	N/A	N/A	Gutter X Slope (%)	N/A
N/A	Painted X Walk1?	No	N/A	Painted X Walk2?	No
	X Walk 1 Direction	To SW		X Walk 2 Direction	To SE
N/A	X Walk 1 Width (in)	N/A	N/A	X Walk 2 Width (in)	N/A
	X Walk 1 Slope (%)	1.3		X Walk 2 Slope (%)	4.5
	X Walk 1 X Slope (%)	3.1		X Walk 2 X Slope (%)	6.8

N/A	Ramp inside XWalk1?	N/A	N/A	Ramp inside XWalk2?	N/A
	Road Slope (%)	1.4	N/A	Clear Space?	N/A
	Road X Slope (%)	2.2	N/A	Clear Space to XWalk (in)	N/A
N/A	Any Obstructions?	N/A	N/A	Storm Grate/Utility Hazard?	N/A
	Obstruction Type			Storm Grate/Utility Type	
		N/A			N/A
			Yes	Surface Condition? (G/P)	Good

**Remove & Replace Curb Ramp With Two New Directional Ramps or Equivalent.**

**R304.2.2**
