Access Compliance Report

Public Rights-of-Way

(Curb Ramps)

Intersection ID: N/A	Main Street: S_CLARKSON_ST	Cross Street: DUNBAR_ST	Location: S
ADA ID: 4993853A3390	Ramp Type: Perp	Initial Pass/Fail: Fail	Overall Compliance: No
Severity Score: 21.25			
Codes/Mitigation Info/Possible Solution		Field Measurements/Component Compliance

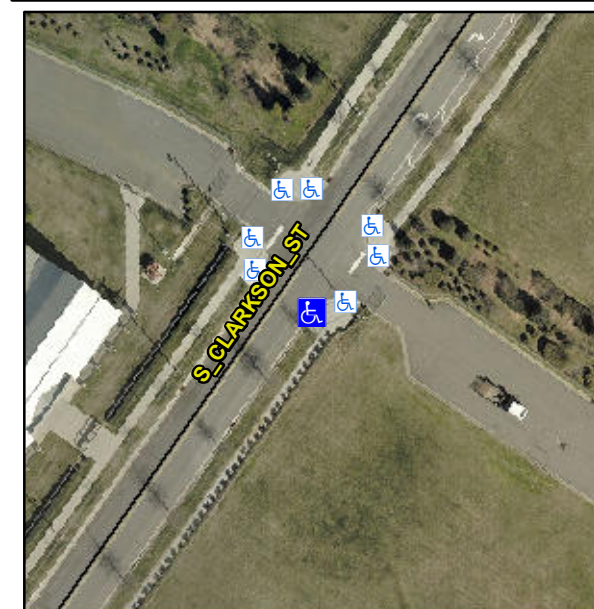
Not Found, R304.5.1, R304.5.3

Compliance	Description	Data	Compliance	Description	Data
N/A	Ramp Length (in)	96.0	Yes	Ramp Slope (%)	6.9
No	Ramp Width (in)	47.0	No	Ramp XSlope (%)	5.1
N/A	Flare Type LT	N/A	N/A	Flare Type RT	N/A
N/A	Flare Slope LT (%)	N/A	N/A	Flare Slope RT (%)	N/A
N/A	Flare Traversable LT?	N/A	N/A	Flare Traversable RT?	N/A
N/A	Landing Length (in)	N/A	N/A	DWS Provided?	N/A
N/A	Landing Width (in)	N/A	N/A	DWS Contrast?	N/A
N/A	Landing Slope (%)	N/A	N/A	DWS Length (in)	N/A
N/A	Landing X Slope (%)	N/A	N/A	DWS Full Width?	N/A
N/A	Landing Curb? (Y/N)	N/A	N/A	DWS Offset (in)	N/A
N/A	Shared Landing?	N/A			
N/A	Gutter Ponding?	N/A	N/A	Gutter Slope (%)	N/A
N/A	Gutter Lip Ht (in)	N/A	N/A	Gutter X Slope (%)	N/A
N/A	Painted X Walk1?	No	N/A	Painted X Walk2?	N/A
	X Walk 1 Direction	To NW		X Walk 2 Direction	N/A
N/A	X Walk 1 Width (in)	N/A	N/A	X Walk 2 Width (in)	N/A
	X Walk 1 Slope (%)	3.2		X Walk 2 Slope (%)	N/A
	X Walk 1 X Slope (%)	1.0		X Walk 2 X Slope (%)	N/A

Remove & Replace Entire Ramp.

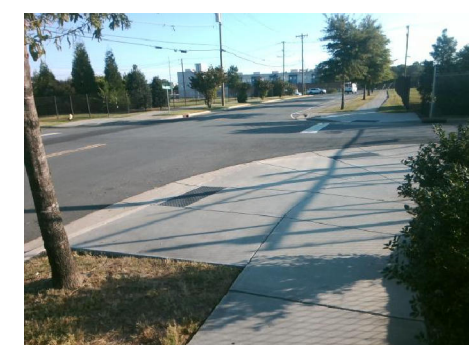
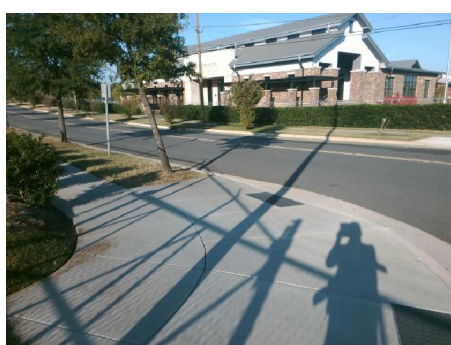
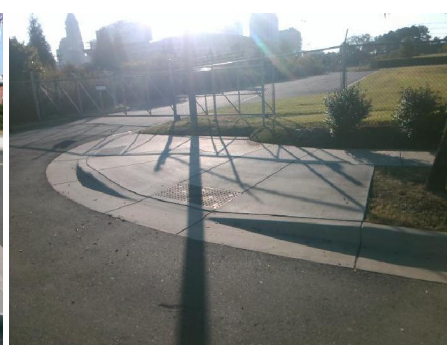
N/A	Ramp inside XWalk1?	N/A	N/A	Ramp inside XWalk2?	N/A
	Road Slope (%)	N/A	N/A	Clear Space?	N/A
	Road X Slope (%)	N/A	N/A	Clear Space to XWalk (in)	N/A
N/A	Any Obstructions?	N/A	N/A	Storm Grate/Utility Hazard?	N/A
	Obstruction Type			Storm Grate/Utility Type	
		N/A			N/A
			Yes	Surface Condition? (G/P)	Good
