# Access Compliance Report

## Public Rights-of-Way

### (Curb Ramps)

| Intersection ID: 18844 | Main Street: NATIONS_FORD_RD | Cross Street: TYVOLA_RD | Location: NE |

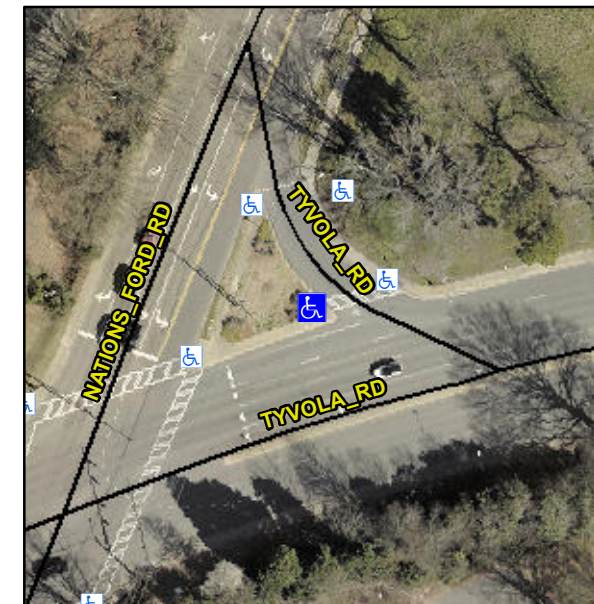
| ADA ID: 499DA1765330 | Ramp Type: IslandPerp | Initial Pass/Fail: Fail | Overall Compliance: No |
| Severity Score: 22.5 | | | |

**Not Found, R304.5.1, R304.2.2, R304.5.3**

| Compliance | Description | Data | Compliance | Description | Data |
|---|---|---|---|---|---|
| N/A | Ramp Length (in) | 60.0 | No | Ramp Slope (%) | 9.0 |
| No | Ramp Width (in) | 39.0 | No | Ramp XSlope (%) | 2.8 |

**Remove & Replace Entire Ramp.**
