Access Compliance Report

Public Rights-of-Way

(Curb Ramps)

Intersection ID: 6220	Main Street: NEAL_RD	Cross Street: RUMSTONE_LN	Location:	N
ADA ID: 499DA8EAE6DA	Ramp Type: PerpDiag	Initial Pass/Fail: Fail	Overall Compliance: No	Severity Score: 21.25

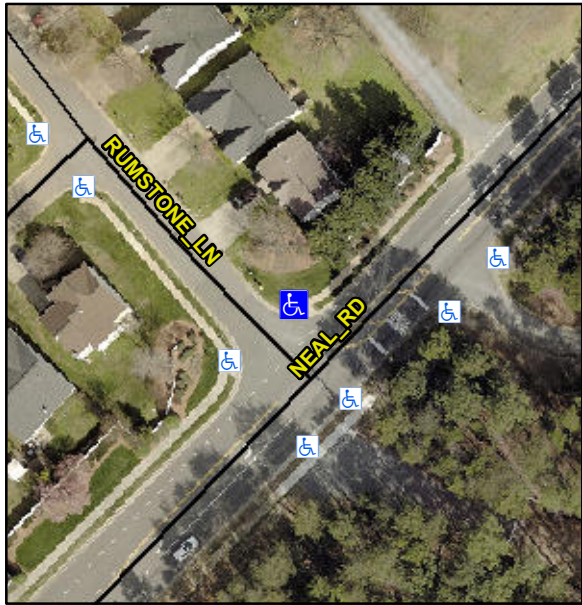
Possible Solutions:		Compliance	Description	Data	Compliance	Description	Data
	Remove & Replace Curb Ramp With Two New Directional Ramps or Equivalent.		N/A	Ramp Length (in)	93.0	No	Ramp Slope (%)	9.5
			No	Ramp Width (in)	46.0	Yes	Ramp XSlope (%)	1.4
			N/A	Flare Type LT	N/A	N/A	Flare Type RT	N/A
			N/A	Flare Slope LT (%)	N/A	N/A	Flare Slope RT (%)	N/A
			N/A	Flare Traversable LT?	N/A	N/A	Flare Traversable RT?	N/A
			N/A	Landing Length (in)	N/A	N/A	DWS Provided?	N/A
			N/A	Landing Width (in)	N/A	N/A	DWS Contrast?	N/A
			N/A	Landing Slope (%)	N/A	N/A	DWS Length (in)	N/A
			N/A	Landing X Slope (%)	N/A	N/A	DWS Full Width?	N/A
Surveyor Notes:		N/A	N/A	Landing Curb? (Y/N)	N/A	N/A	DWS Offset (in)	N/A
PROW/ADA:		Not Found, R304.5.1, R304.2.2	N/A	Shared Landing?	N/A			
			N/A	Gutter Ponding?	N/A	N/A	Gutter Slope (%)	N/A

N/A	Gutter Lip Ht (in)	0.5	N/A	Gutter X Slope (%)	N/A
			N/A	Painted X Walk1?	No	N/A	Painted X Walk2?	No
				X Walk 1 Direction	To SW		X Walk 2 Direction	To SE
			N/A	X Walk 1 Width (in)	N/A	N/A	X Walk 2 Width (in)	N/A
				X Walk 1 Slope (%)	1.6		X Walk 2 Slope (%)	3.1
				X Walk 1 X Slope (%)	1.8		X Walk 2 X Slope (%)	1.6
			N/A	Ramp inside XWalk1?	N/A	N/A	Ramp inside XWalk2?	N/A
				Road Slope (%)	1.2	N/A	Clear Space?	N/A
				Road X Slope (%)	3.8	N/A	Clear Space to XWalk (in)	N/A
			N/A	Any Obstructions?	N/A	N/A	Storm Grate/Utility Hazard?	N/A
				Obstruction Type			Storm Grate/Utility Type	
					N/A			N/A
						Yes	Surface Condition? (G/P)	Good
Street 1 Name		RUMSTONE LN						
Stop Condition-Street 2		StopSign						
Street 2 Name		NEAL RD						
Stop Condition-Street 1		None						
Total Cost:		\$ 3200.00
