Access Compliance Report

Public Rights-of-Way

(Curb Ramps)

Intersection ID: 7126	Main Street: HAMMONDS_ST	Cross Street: HOUSTON_ST	Location: W
ADA ID: 49A87C3F18E8	Ramp Type: Perp	Initial Pass/Fail: Fail	Overall Compliance: No
			Severity Score: 18.75

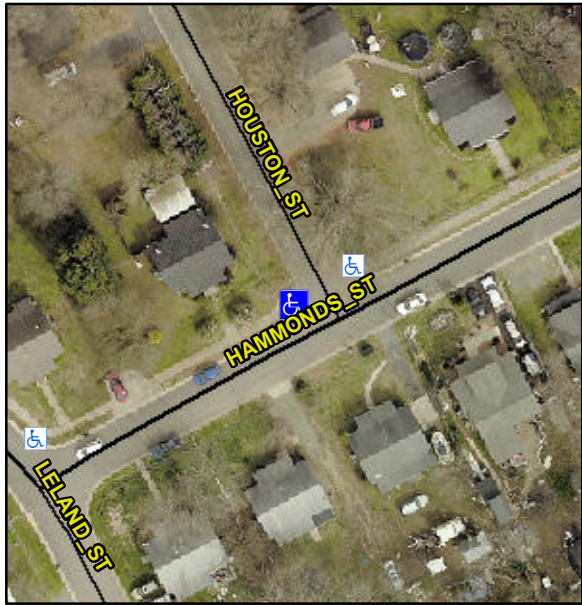
Possible Solutions:		Compliance	Description	Data	Compliance	Description	Data
	Remove & Replace Entire Ramp.		N/A	Ramp Length (in)	50.0	Yes	Ramp Slope (%)	5.0
			No	Ramp Width (in)	33.0	No	Ramp XSlope (%)	2.4
			N/A	Flare Type LT	N/A	N/A	Flare Type RT	N/A
			N/A	Flare Slope LT (%)	N/A	N/A	Flare Slope RT (%)	N/A
			N/A	Flare Traversable LT?	N/A	N/A	Flare Traversable RT?	N/A
			N/A	Landing Length (in)	N/A	N/A	DWS Provided?	N/A
			N/A	Landing Width (in)	N/A	N/A	DWS Contrast?	N/A
			N/A	Landing Slope (%)	N/A	N/A	DWS Length (in)	N/A
			N/A	Landing X Slope (%)	N/A	N/A	DWS Full Width?	N/A
Surveyor Notes:		N/A	N/A	Landing Curb? (Y/N)	N/A	N/A	DWS Offset (in)	N/A
			N/A	Shared Landing?	N/A			
PROW/ADA:			N/A	Gutter Ponding?	N/A	N/A	Gutter Slope (%)	N/A
Not Found, R304.5.1, R304.5.3			N/A	Gutter Lip Ht (in)	N/A	N/A	Gutter X Slope (%)	N/A

N/A	Painted X Walk1?	No	N/A	Painted X Walk2?	N/A
				X Walk 1 Direction	To E		X Walk 2 Direction	N/A
			N/A	X Walk 1 Width (in)	N/A	N/A	X Walk 2 Width (in)	N/A
				X Walk 1 Slope (%)	5.0		X Walk 2 Slope (%)	N/A
				X Walk 1 X Slope (%)	3.0		X Walk 2 X Slope (%)	N/A
			N/A	Ramp inside XWalk1?	N/A	N/A	Ramp inside XWalk2?	N/A
				Road Slope (%)	N/A	N/A	Clear Space?	N/A
				Road X Slope (%)	N/A	N/A	Clear Space to XWalk (in)	N/A
			N/A	Any Obstructions?	N/A	N/A	Storm Grate/Utility Hazard?	N/A
				Obstruction Type			Storm Grate/Utility Type	
					N/A			N/A
						Yes	Surface Condition? (G/P)	Good
Street 1 Name		HOUSTON ST						
Stop Condition-Street 2		StopSign						
Street 2 Name		N/A						
Stop Condition-Street 1		N/A						
Total Cost:		\$ 1850.00
