Intersection ID: 14182		Main Street: E_PARK_AV	Cross Street: LYNDHURST_AV	Location:	W																																																																																																																																																						
ADA ID: 49A9D661C02E		Ramp Type: Directional1	Initial Pass/Fail: Fail	Overall Compliance: No	Severity Score: 26.25																																																																																																																																																						
Codes/Mitigation Info/Possible Solution			Field Measurements/Component Compliance																																																																																																																																																								
<div>

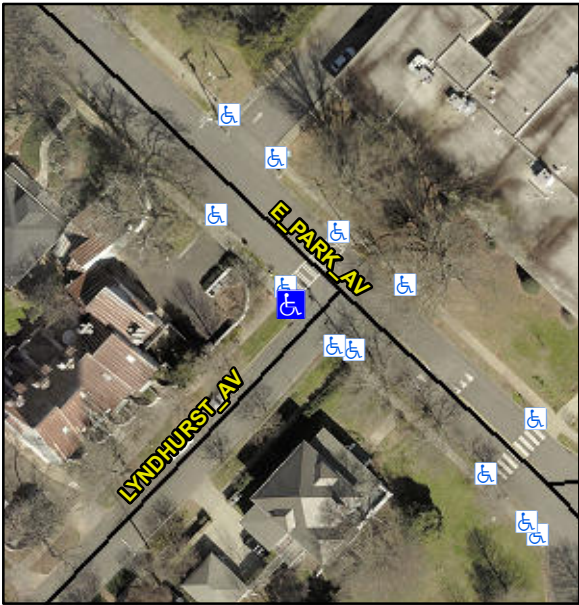
<table><tr><th>Compliance</th><th>Description</th><th>Data</th><th>Compliance</th><th>Description</th><th>Data</th></tr><tr><td>No</td><td>Ramp Slope (%)</td><td>12.0</td><td>N/A</td><td>Grade Break XSlope (%)</td><td>0.0</td></tr><tr><td>No</td><td>Ramp XSlope (%)</td><td>2.2</td><td></td><td></td><td></td></tr></table>

</div> <div>Possible Solutions: Remove & Replace Entire Ramp.</div> <div>Surveyor Notes: N/A</div> <div>PROW/ADA: R304.2.2, R304.5.3</div> <div><div>Street 1 Name Stop Condition-Street 1 Street 2 Name Stop Condition-Street 2</div><div>LYNDHURST AV StopSign N/A N/A</div></div> <div>Total Cost: \$ 1600.00</div>
