Access Compliance Report

Public Rights-of-Way

(Curb Ramps)

| Intersection ID: N/A | Main Street: E_ARROWWOOD_RD | Cross Street: N/A | Location: S |

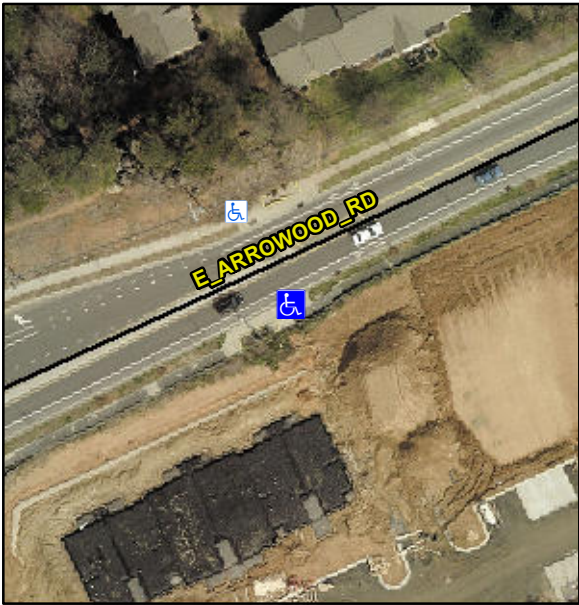
| ADA ID: 49AB2C30554F | Ramp Type: Perp | Initial Pass/Fail: Fail | Overall Compliance: No |

| Codes/Mitigation Info/Possible Solution | | | Field Measurements/Component Compliance | | | | | |
|--|---|---|---|---|---|---|---|---|
| | Remove & Replace Entire Ramp. | | N/A | Ramp Length (in) | 72.0 | No | Ramp Slope (%) | 8.9 |
| | | | Yes | Ramp Width (in) | 60.0 | No | Ramp XSlope (%) | 7.8 |
| PROW/ADA: | | Not Found, R304.2.2, R304.5.3 | N/A | Shared Landing? | N/A | | | |

| Codes/Mitigation Info/Possible Solution | | | Field Measurements/Component Compliance | | | | | |
|--|---|---|---|---|---|---|---|---|
| | Possible Solutions: | | Compliance | Description | Data | Compliance | Description | Data |
