Access Compliance Report

Public Rights-of-Way

(Curb Ramps)

Intersection ID: 31430	Main Street: BRAWER_FARM_DR	Cross Street: HEYSHAM_LN	Location: S
ADA ID: 49B9E2CBDA7E	Ramp Type: BlendTrans1	Initial Pass/Fail: Pass	Overall Compliance: No
Codes/Mitigation Info/Possible Solution		Field Measurements/Component Compliance	
Severity Score: 10

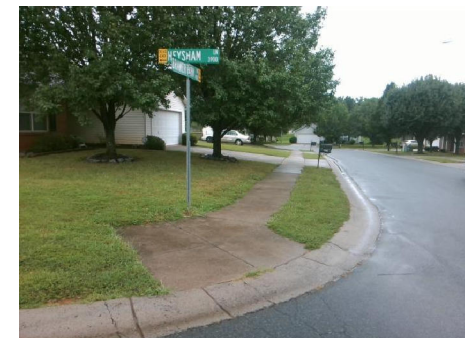
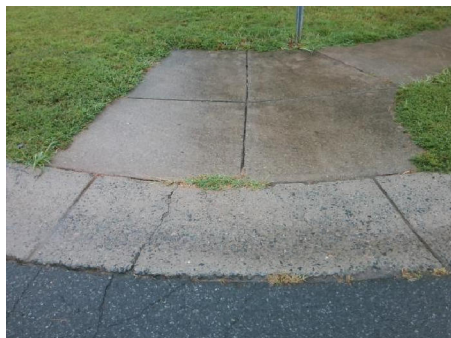
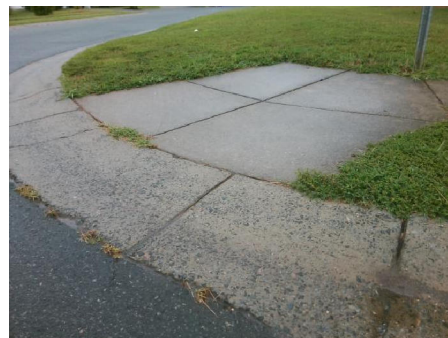
NO LT SW

Compliance	Description	Data	Compliance	Description	Data
N/A	Ramp Length (in)	42.5	Yes	BlendTrans Slope (%)	4.6
Yes	Ramp Width (in)	61.0	Yes	BlendTrans XSlope (%)	1.8
N/A	Flare Type LT	None	N/A	Flare Type RT	None
N/A	Flare Slope LT (%)	N/A	N/A	Flare Slope RT (%)	N/A
N/A	Flare Traversable LT?	N/A	N/A	Flare Traversable RT?	N/A
Yes	Landing Length (in)	53.0	No	DWS Provided?	No
Yes	Landing Width (in)	62.0	N/A	DWS Contrast?	No
No	Landing Slope (%)	4.3	N/A	DWS Length (in)	N/A
Yes	Landing X Slope (%)	0.7	N/A	DWS Full Width?	No
N/A	Landing Curb? (Y/N)	No	N/A	DWS Offset (in)	N/A
N/A	Shared Landing?	No			
Yes	Gutter Ponding?	No	Yes	Gutter Slope (%)	1.4
Yes	Gutter Lip Ht (in)	0.0	No	Gutter X Slope (%)	3.1
N/A	Painted X Walk1?	No	N/A	Painted X Walk2?	No
	X Walk 1 Direction	To NE		X Walk 2 Direction	To NW
	X Walk 1 Width (in)	N/A		X Walk 2 Width (in)	N/A
	X Walk 1 Slope (%)	3.5		X Walk 2 Slope (%)	2.0
	X Walk 1 X Slope (%)	0.4		X Walk 2 X Slope (%)	3.3

N/A	Ramp inside XWalk1?	N/A	N/A	Ramp inside XWalk2?	N/A
	Road Slope (%)	2.3		Clear Space?	Yes
	Road X Slope (%)	1.8	N/A	Clear Space to XWalk (in)	N/A
Yes	Any Obstructions?	No	Yes	Storm Grate/Utility Hazard?	No
	Obstruction Type			Storm Grate/Utility Type	
		N/A			N/A
			Yes	Surface Condition? (G/P)	Good
			No	Curb Slope (%)	8.3

Possible Solutions:

Remove & Replace Curb Ramp With Two New Directional Ramps or Equivalent. Remove & Replace Gutter.
