Access Compliance Report

Public Rights-of-Way

(Curb Ramps)

Intersection ID: 11436	Main Street: E_19TH_ST	Cross Street: N_DAVIDSON_ST	Location: NE
ADA ID: 49C10E315E93	Ramp Type: PerpDiag	Initial Pass/Fail: Fail	Overall Compliance: No
		Severity Score: 12.5

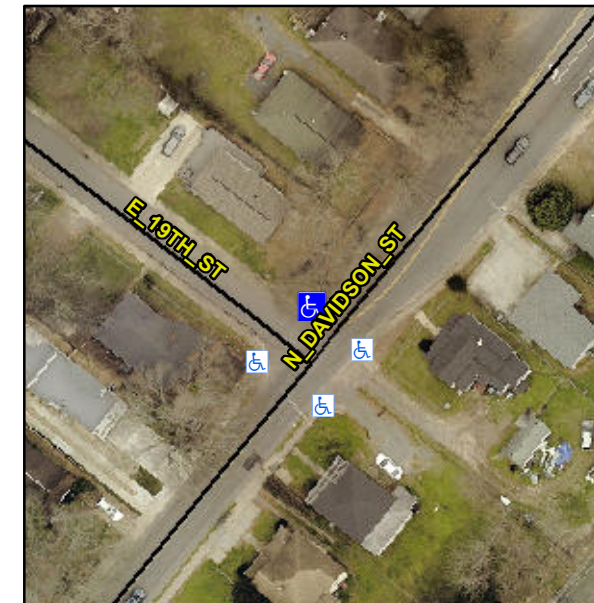
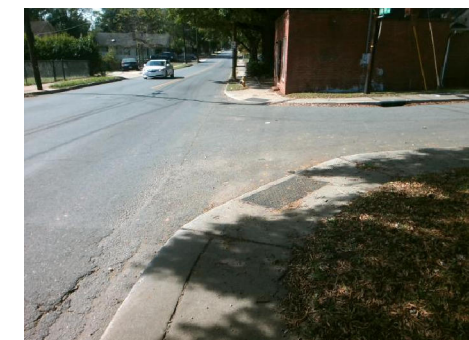
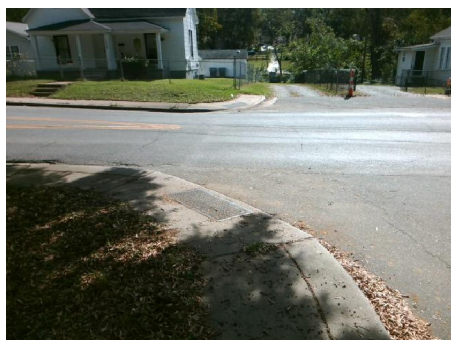
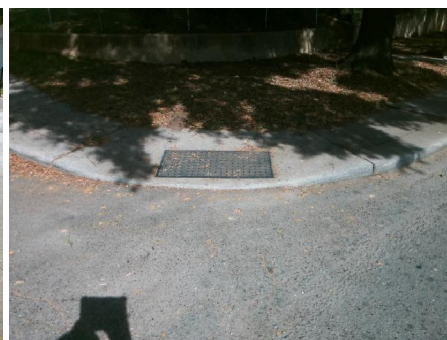
Compliance	Description	Data	Compliance	Description	Data
N/A	Ramp Length (in)	55.0	No	Ramp Slope (%)	11.0
Yes	Ramp Width (in)	48.0	Yes	Ramp XSlope (%)	1.2
N/A	Flare Type LT	N/A	N/A	Flare Type RT	N/A
N/A	Flare Slope LT (%)	N/A	N/A	Flare Slope RT (%)	N/A
N/A	Flare Traversable LT?	N/A	N/A	Flare Traversable RT?	N/A
N/A	Landing Length (in)	N/A	N/A	DWS Provided?	N/A
N/A	Landing Width (in)	N/A	N/A	DWS Contrast?	N/A
N/A	Landing Slope (%)	N/A	N/A	DWS Length (in)	N/A
N/A	Landing X Slope (%)	N/A	N/A	DWS Full Width?	N/A
N/A	Landing Curb? (Y/N)	N/A	N/A	DWS Offset (in)	N/A
N/A	Shared Landing?	N/A			
N/A	Gutter Ponding?	N/A	N/A	Gutter Slope (%)	N/A
N/A	Gutter Lip Ht (in)	1.5	N/A	Gutter X Slope (%)	N/A
N/A	Painted X Walk1?	No	N/A	Painted X Walk2?	No
	X Walk 1 Direction	To SW		X Walk 2 Direction	To SE
N/A	X Walk 1 Width (in)	N/A	N/A	X Walk 2 Width (in)	N/A
	X Walk 1 Slope (%)	0.1		X Walk 2 Slope (%)	1.1
	X Walk 1 X Slope (%)	2.5		X Walk 2 X Slope (%)	1.9

N/A	Ramp inside XWalk1?	N/A	N/A	Ramp inside XWalk2?	N/A
	Road Slope (%)	0.6	N/A	Clear Space?	N/A
	Road X Slope (%)	1.0	N/A	Clear Space to XWalk (in)	N/A
N/A	Any Obstructions?	N/A	N/A	Storm Grate/Utility Hazard?	N/A
	Obstruction Type			Storm Grate/Utility Type	
		N/A			N/A
			Yes	Surface Condition? (G/P)	Good

Remove & Replace Curb Ramp With Two New Directional Ramps or Equivalent.

R304.2.2
