Access Compliance Report

Public Rights-of-Way

(Curb Ramps)

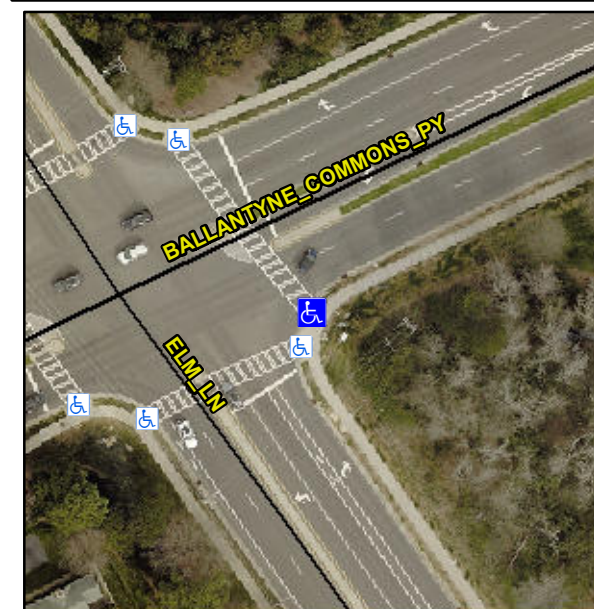
Intersection ID: 27397	Main Street: ELM_LN	Cross Street: BALLANTYNE_COMMONS_PY	Location: SE
ADA ID: 49CA8C133B79	Ramp Type: Perp	Initial Pass/Fail: Fail	Overall Compliance: No
Severity Score: 22.5			
Codes/Mitigation Info/Possible Solution		Field Measurements/Component Compliance

Not Found, R304.5.1, R304.2.2, R304.5.3

Compliance	Description	Data	Compliance	Description	Data
N/A	Ramp Length (in)	48.0	No	Ramp Slope (%)	8.7
No	Ramp Width (in)	47.0	No	Ramp XSlope (%)	2.9
N/A	Flare Type LT	N/A	N/A	Flare Type RT	N/A
N/A	Flare Slope LT (%)	N/A	N/A	Flare Slope RT (%)	N/A
N/A	Flare Traversable LT?	N/A	N/A	Flare Traversable RT?	N/A
N/A	Landing Length (in)	N/A	N/A	DWS Provided?	N/A
N/A	Landing Width (in)	N/A	N/A	DWS Contrast?	N/A
N/A	Landing Slope (%)	N/A	N/A	DWS Length (in)	N/A
N/A	Landing X Slope (%)	N/A	N/A	DWS Full Width?	N/A
N/A	Landing Curb? (Y/N)	N/A	N/A	DWS Offset (in)	N/A
N/A	Shared Landing?	N/A			
N/A	Gutter Ponding?	N/A	N/A	Gutter Slope (%)	N/A
N/A	Gutter Lip Ht (in)	N/A	N/A	Gutter X Slope (%)	N/A
N/A	Painted X Walk1?	Yes	N/A	Painted X Walk2?	N/A
	X Walk 1 Direction	To NW		X Walk 2 Direction	N/A
N/A	X Walk 1 Width (in)	113.0	N/A	X Walk 2 Width (in)	N/A
	X Walk 1 Slope (%)	0.8		X Walk 2 Slope (%)	N/A
	X Walk 1 X Slope (%)	2.0		X Walk 2 X Slope (%)	N/A

N/A	Ramp inside XWalk1?	Yes	N/A	Ramp inside XWalk2?	N/A
	Road Slope (%)	N/A	N/A	Clear Space?	N/A
	Road X Slope (%)	N/A	N/A	Clear Space to XWalk (in)	N/A
N/A	Any Obstructions?	N/A	N/A	Storm Grate/Utility Hazard?	N/A
	Obstruction Type			Storm Grate/Utility Type	
		N/A			N/A
			Yes	Surface Condition? (G/P)	Good

Possible Solutions:

Remove & Replace Entire Ramp.

Total Cost: \$ 1850.00
