Access Compliance Report

Public Rights-of-Way

(Curb Ramps)

Intersection ID: 50617	Main Street: GOLDEN_WOOD_LN	Cross Street: PADDLE_OAK_RD	Location: SW
ADA ID: 49E23C2581D5	Ramp Type: Perp	Initial Pass/Fail: Fail	Overall Compliance: No
Severity Score: 35			
Codes/Mitigation Info/Possible Solution		Field Measurements/Component Compliance

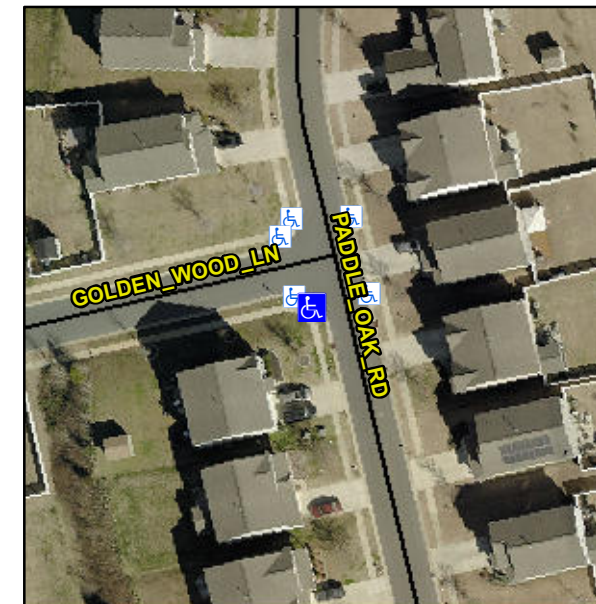
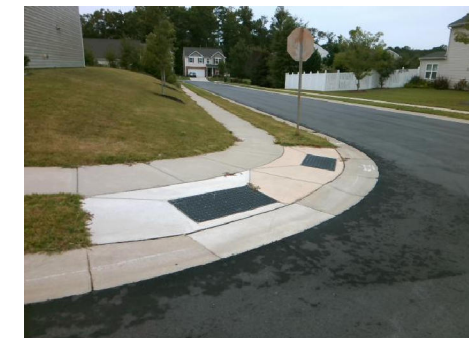
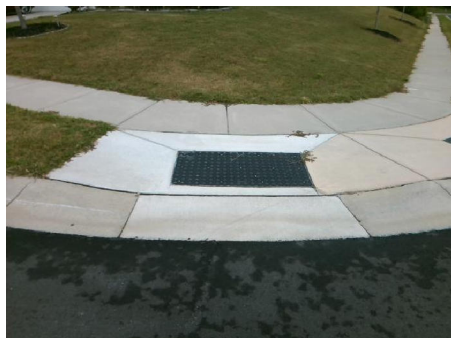
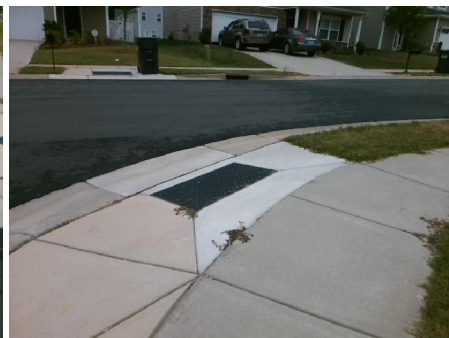
Compliance	Description	Data	Compliance	Description	Data
N/A	Ramp Length (in)	47.0	No	Ramp Slope (%)	12.3
No	Ramp Width (in)	47.5	No	Ramp XSlope (%)	4.4
N/A	Flare Type LT	N/A	N/A	Flare Type RT	N/A
N/A	Flare Slope LT (%)	N/A	N/A	Flare Slope RT (%)	N/A
N/A	Flare Traversable LT?	N/A	N/A	Flare Traversable RT?	N/A
N/A	Landing Length (in)	N/A	N/A	DWS Provided?	N/A
N/A	Landing Width (in)	N/A	N/A	DWS Contrast?	N/A
N/A	Landing Slope (%)	N/A	N/A	DWS Length (in)	N/A
N/A	Landing X Slope (%)	N/A	N/A	DWS Full Width?	N/A
N/A	Landing Curb? (Y/N)	N/A	N/A	DWS Offset (in)	N/A
N/A	Shared Landing?	N/A			
N/A	Gutter Ponding?	N/A	N/A	Gutter Slope (%)	N/A
N/A	Gutter Lip Ht (in)	N/A	N/A	Gutter X Slope (%)	N/A
N/A	Painted X Walk1?	No	N/A	Painted X Walk2?	N/A
	X Walk 1 Direction	To E		X Walk 2 Direction	N/A
N/A	X Walk 1 Width (in)	N/A	N/A	X Walk 2 Width (in)	N/A
	X Walk 1 Slope (%)	2.3		X Walk 2 Slope (%)	N/A
	X Walk 1 X Slope (%)	3.4		X Walk 2 X Slope (%)	N/A

N/A	Ramp inside XWalk1?	N/A	N/A	Ramp inside XWalk2?	N/A
	Road Slope (%)	N/A	N/A	Clear Space?	N/A
	Road X Slope (%)	N/A	N/A	Clear Space to XWalk (in)	N/A
N/A	Any Obstructions?	N/A	N/A	Storm Grate/Utility Hazard?	N/A
	Obstruction Type			Storm Grate/Utility Type	
		N/A			N/A
			Yes	Surface Condition? (G/P)	Good

Possible Solutions:

Remove & Replace Entire Ramp.

R304.5.1, R304.2.2, R304.5.3
