# Access Compliance Report

## Public Rights-of-Way

### (Curb Ramps)

Intersection ID: 11787	Main Street: CAMP_GREENE_ST	Cross Street: HERBERT_SPAUGH_LN	Location: NW
ADA ID: 49EA79BADD59	Ramp Type: Perp	Initial Pass/Fail: Fail	Overall Compliance: No
		Severity Score: 25

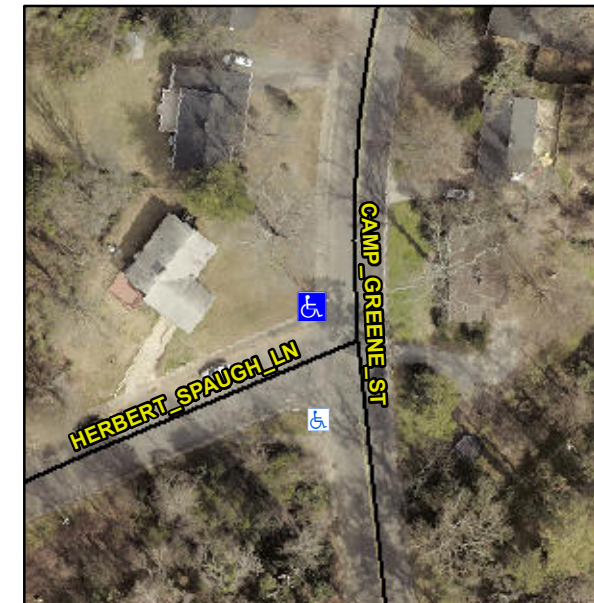
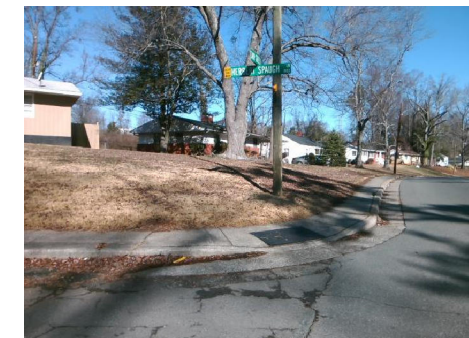
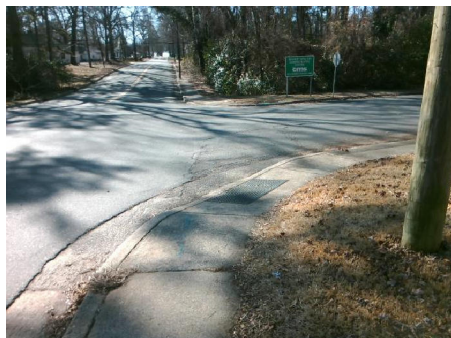
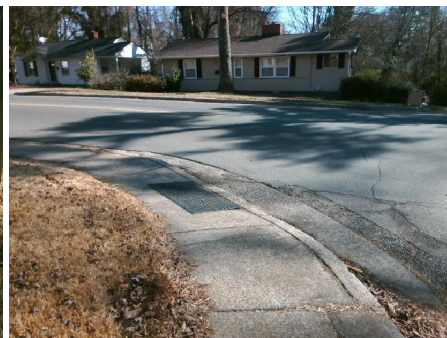
**Not Found, R304.2.2**

Compliance	Description	Data	Compliance	Description	Data
N/A	Ramp Length (in)	46.0	No	Ramp Slope (%)	15.5
Yes	Ramp Width (in)	48.0	Yes	Ramp XSlope (%)	1.7
N/A	Flare Type LT	N/A	N/A	Flare Type RT	N/A
N/A	Flare Slope LT (%)	N/A	N/A	Flare Slope RT (%)	N/A
N/A	Flare Traversable LT?	N/A	N/A	Flare Traversable RT?	N/A
N/A	Landing Length (in)	N/A	N/A	DWS Provided?	N/A
N/A	Landing Width (in)	N/A	N/A	DWS Contrast?	N/A
N/A	Landing Slope (%)	N/A	N/A	DWS Length (in)	N/A
N/A	Landing X Slope (%)	N/A	N/A	DWS Full Width?	N/A
N/A	Landing Curb? (Y/N)	N/A	N/A	DWS Offset (in)	N/A
N/A	Shared Landing?	N/A			
N/A	Gutter Ponding?	N/A	N/A	Gutter Slope (%)	N/A
N/A	Gutter Lip Ht (in)	N/A	N/A	Gutter X Slope (%)	N/A
N/A	Painted X Walk1?	No	N/A	Painted X Walk2?	N/A
	X Walk 1 Direction	To S		X Walk 2 Direction	N/A
N/A	X Walk 1 Width (in)	N/A	N/A	X Walk 2 Width (in)	N/A
	X Walk 1 Slope (%)	2.7		X Walk 2 Slope (%)	N/A
	X Walk 1 X Slope (%)	2.4		X Walk 2 X Slope (%)	N/A

N/A	Ramp inside XWalk1?	N/A	N/A	Ramp inside XWalk2?	N/A
	Road Slope (%)	N/A	N/A	Clear Space?	N/A
	Road X Slope (%)	N/A	N/A	Clear Space to XWalk (in)	N/A
N/A	Any Obstructions?	N/A	N/A	Storm Grate/Utility Hazard?	N/A
	Obstruction Type			Storm Grate/Utility Type	
		N/A			N/A
			Yes	Surface Condition? (G/P)	Good

**Remove & Replace Entire Ramp.**

Total Cost: \$ 1850.00
