Access Compliance Report

Public Rights-of-Way

(Curb Ramps)

Intersection ID: 10037250	Main Street: SARDIS_HALL_CT	Cross Street: N/A	Location: N
ADA ID: 49ED038F1B31	Ramp Type: Perp	Initial Pass/Fail: Fail	Overall Compliance: No
Severity Score: 8.75			
Codes/Mitigation Info/Possible Solution		Field Measurements/Component Compliance

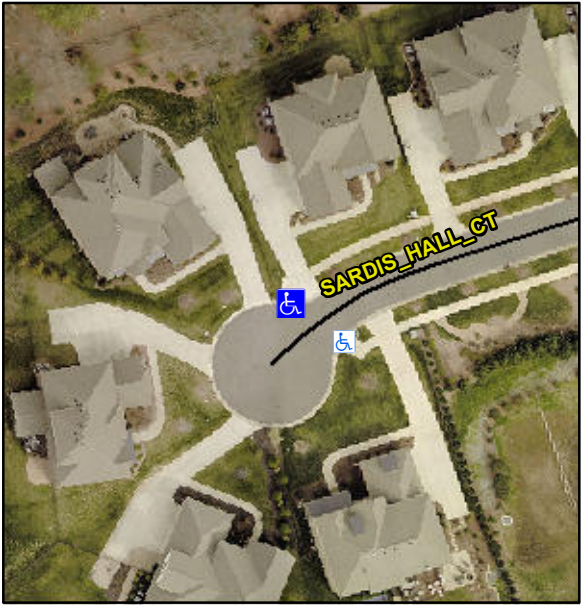
Possible Solutions:						
	Remove & Replace Entire Ramp.						
	Surveyor Notes:	Compliance	Description	Data	Compliance	Description	Data
		N/A	Ramp Length (in)	95.0	Yes	Ramp Slope (%)	7.9
		No	Ramp Width (in)	46.5	Yes	Ramp XSlope (%)	1.1
		N/A	Flare Type LT	N/A	N/A	Flare Type RT	N/A
		N/A	Flare Slope LT (%)	N/A	N/A	Flare Slope RT (%)	N/A
		N/A	Flare Traversable LT?	N/A	N/A	Flare Traversable RT?	N/A
		N/A	Landing Length (in)	N/A	N/A	DWS Provided?	N/A
		N/A	Landing Width (in)	N/A	N/A	DWS Contrast?	N/A
		N/A	Landing Slope (%)	N/A	N/A	DWS Length (in)	N/A
		N/A	Landing X Slope (%)	N/A	N/A	DWS Full Width?	N/A
<p>PROW/ADA:</p> <p>Not Found, R304.5.1</p>	N/A	N/A	Landing Curb? (Y/N)	N/A	N/A	DWS Offset (in)	N/A
		N/A	Shared Landing?	N/A			
		N/A	Gutter Ponding?	N/A	N/A	Gutter Slope (%)	N/A
		N/A	Gutter Lip Ht (in)	N/A	N/A	Gutter X Slope (%)	N/A
		N/A	Painted X Walk1?	No	N/A	Painted X Walk2?	N/A
			X Walk 1 Direction	To SE		X Walk 2 Direction	N/A

N/A	X Walk 1 Width (in)	N/A	N/A	X Walk 2 Width (in)	N/A
			X Walk 1 Slope (%)	2.1		X Walk 2 Slope (%)	N/A
			X Walk 1 X Slope (%)	2.3		X Walk 2 X Slope (%)	N/A
		N/A	Ramp inside XWalk1?	N/A	N/A	Ramp inside XWalk2?	N/A
<p>Total Cost: \$ 1850.00</p>			Road Slope (%)	N/A	N/A	Clear Space?	N/A
			Road X Slope (%)	N/A	N/A	Clear Space to XWalk (in)	N/A
		N/A	Any Obstructions?	N/A	N/A	Storm Grate/Utility Hazard?	N/A
			Obstruction Type			Storm Grate/Utility Type	
				N/A			N/A
					Yes	Surface Condition? (G/P)	Good
