Access Compliance Report

Public Rights-of-Way

(Curb Ramps)

Intersection ID: 44173	Main Street: BELLEGARDE_DR	Cross Street: BOBHOUSE_DR	Location: SW
ADA ID: 49EDF0D7A9E0	Ramp Type: PerpDiag	Initial Pass/Fail: Fail	Overall Compliance: No
		Severity Score: 47.5

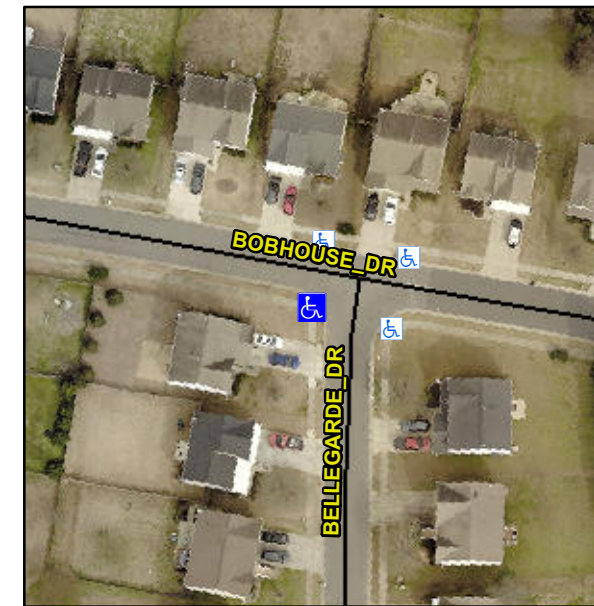
Not Found, R304.5.1, R304.2.2

Compliance	Description	Data	Compliance	Description	Data
N/A	Ramp Length (in)	46.5	No	Ramp Slope (%)	8.4
No	Ramp Width (in)	31.0	Yes	Ramp XSlope (%)	1.2
N/A	Flare Type LT	N/A	N/A	Flare Type RT	N/A
N/A	Flare Slope LT (%)	N/A	N/A	Flare Slope RT (%)	N/A
N/A	Flare Traversable LT?	N/A	N/A	Flare Traversable RT?	N/A
N/A	Landing Length (in)	N/A	N/A	DWS Provided?	N/A
N/A	Landing Width (in)	N/A	N/A	DWS Contrast?	N/A
N/A	Landing Slope (%)	N/A	N/A	DWS Length (in)	N/A
N/A	Landing X Slope (%)	N/A	N/A	DWS Full Width?	N/A
N/A	Landing Curb? (Y/N)	N/A	N/A	DWS Offset (in)	N/A
N/A	Shared Landing?	N/A			
N/A	Gutter Ponding?	N/A	N/A	Gutter Slope (%)	N/A
N/A	Gutter Lip Ht (in)	1.0	N/A	Gutter X Slope (%)	N/A
N/A	Painted X Walk1?	No	N/A	Painted X Walk2?	No
	X Walk 1 Direction	To SE		X Walk 2 Direction	To NE
N/A	X Walk 1 Width (in)	N/A	N/A	X Walk 2 Width (in)	N/A
	X Walk 1 Slope (%)	0.5		X Walk 2 Slope (%)	3.2
	X Walk 1 X Slope (%)	2.5		X Walk 2 X Slope (%)	2.5

N/A	Ramp inside XWalk1?	N/A	N/A	Ramp inside XWalk2?	N/A
	Road Slope (%)	2.8	N/A	Clear Space?	N/A
	Road X Slope (%)	2.8	N/A	Clear Space to XWalk (in)	N/A
N/A	Any Obstructions?	N/A	N/A	Storm Grate/Utility Hazard?	N/A
	Obstruction Type			Storm Grate/Utility Type	
		N/A			N/A
			Yes	Surface Condition? (G/P)	Good

Remove & Replace Curb Ramp With Two New Directional Ramps or Equivalent.
