Access Compliance Report

Public Rights-of-Way

(Curb Ramps)

Intersection ID: 43922	Main Street: NORTH_COMMUNITY_HOUSE_RD	Cross Street: JOHNSTON_RD	Location: NW
ADA ID: 49F2AC8CCFA9	Ramp Type: Perp	Initial Pass/Fail: Fail	Overall Compliance: No
			Severity Score: 18.75

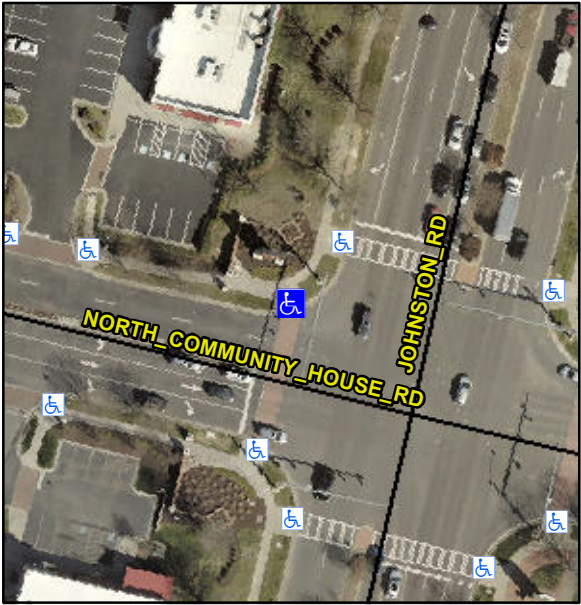
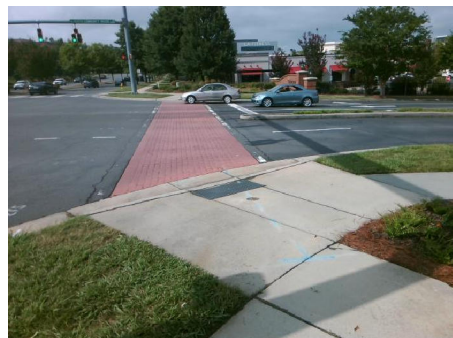
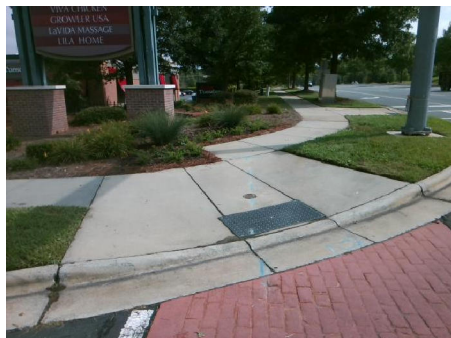
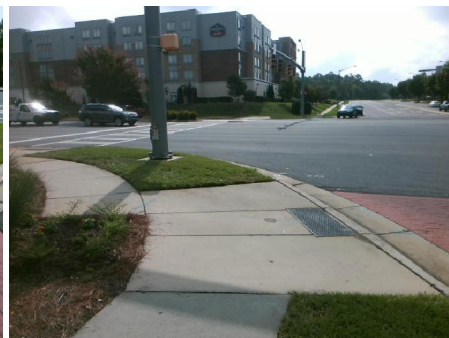
Compliance	Description	Data	Compliance	Description	Data
N/A	Ramp Length (in)	118.0	Yes	Ramp Slope (%)	5.2
No	Ramp Width (in)	35.0	No	Ramp XSlope (%)	4.9
N/A	Flare Type LT	N/A	N/A	Flare Type RT	N/A
N/A	Flare Slope LT (%)	N/A	N/A	Flare Slope RT (%)	N/A
N/A	Flare Traversable LT?	N/A	N/A	Flare Traversable RT?	N/A
N/A	Landing Length (in)	N/A	N/A	DWS Provided?	N/A
N/A	Landing Width (in)	N/A	N/A	DWS Contrast?	N/A
N/A	Landing Slope (%)	N/A	N/A	DWS Length (in)	N/A
N/A	Landing X Slope (%)	N/A	N/A	DWS Full Width?	N/A
N/A	Landing Curb? (Y/N)	N/A	N/A	DWS Offset (in)	N/A
N/A	Shared Landing?	N/A			
N/A	Gutter Ponding?	N/A	N/A	Gutter Slope (%)	N/A
N/A	Gutter Lip Ht (in)	N/A	N/A	Gutter X Slope (%)	N/A
N/A	Painted X Walk1?	Yes	N/A	Painted X Walk2?	N/A
	X Walk 1 Direction	To SW		X Walk 2 Direction	N/A
N/A	X Walk 1 Width (in)	118.0	N/A	X Walk 2 Width (in)	N/A
	X Walk 1 Slope (%)	1.8		X Walk 2 Slope (%)	N/A
	X Walk 1 X Slope (%)	2.5		X Walk 2 X Slope (%)	N/A

N/A	Ramp inside XWalk1?	Yes	N/A	Ramp inside XWalk2?	N/A
	Road Slope (%)	N/A	N/A	Clear Space?	N/A
	Road X Slope (%)	N/A	N/A	Clear Space to XWalk (in)	N/A
N/A	Any Obstructions?	N/A	N/A	Storm Grate/Utility Hazard?	N/A
	Obstruction Type			Storm Grate/Utility Type	
		N/A			N/A
			Yes	Surface Condition? (G/P)	Good

Possible Solutions:				
	Remove & Replace Entire Ramp.				
	Surveyor Notes:				
	N/A				
	PROW/ADA:				
	R304.5.1, R304.5.3				
Street 1 Name	NORTH COMMUNITY HOUSE RD				
Stop Condition-Street 2	Signal				
Street 2 Name	N/A				
Stop Condition-Street 1	N/A				
Total Cost:		\$	1850.00
