Access Compliance Report

Public Rights-of-Way

(Curb Ramps)

Intersection ID: 11674	Main Street: GRAHAM_ST	Cross Street: HEARN_PL	Location:	N
ADA ID: 4A02C1341BE9	Ramp Type: PerpDiag	Initial Pass/Fail: Fail	Overall Compliance: No	Severity Score: 13.75
Codes/Mitigation Info/Possible Solution		Field Measurements/Component Compliance

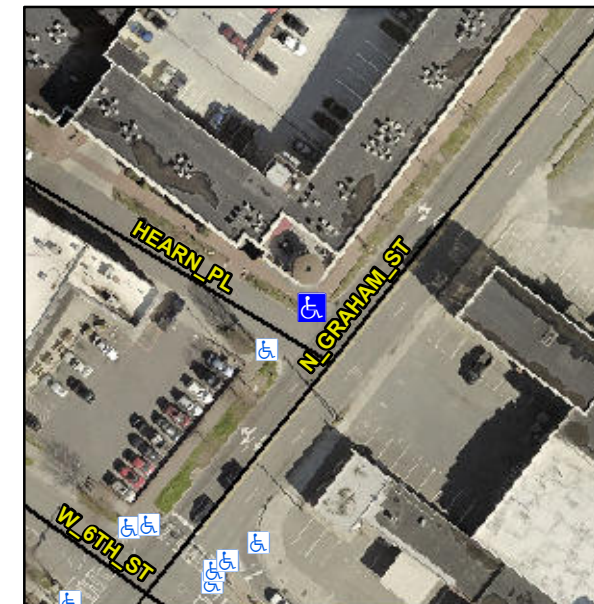
Not Found, R304.2.2, R304.5.3

Compliance	Description	Data	Compliance	Description	Data
N/A	Ramp Length (in)	28.0	No	Ramp Slope (%)	10.3
Yes	Ramp Width (in)	48.0	No	Ramp XSlope (%)	2.5
N/A	Flare Type LT	N/A	N/A	Flare Type RT	N/A
N/A	Flare Slope LT (%)	N/A	N/A	Flare Slope RT (%)	N/A
N/A	Flare Traversable LT?	N/A	N/A	Flare Traversable RT?	N/A
N/A	Landing Length (in)	N/A	N/A	DWS Provided?	N/A
N/A	Landing Width (in)	N/A	N/A	DWS Contrast?	N/A
N/A	Landing Slope (%)	N/A	N/A	DWS Length (in)	N/A
N/A	Landing X Slope (%)	N/A	N/A	DWS Full Width?	N/A
N/A	Landing Curb? (Y/N)	N/A	N/A	DWS Offset (in)	N/A
N/A	Shared Landing?	N/A			
N/A	Gutter Ponding?	N/A	N/A	Gutter Slope (%)	N/A
N/A	Gutter Lip Ht (in)	N/A	N/A	Gutter X Slope (%)	N/A
N/A	Painted X Walk1?	No	N/A	Painted X Walk2?	No
	X Walk 1 Direction	To SW		X Walk 2 Direction	To SE
N/A	X Walk 1 Width (in)	N/A	N/A	X Walk 2 Width (in)	N/A
	X Walk 1 Slope (%)	1.8		X Walk 2 Slope (%)	4.5
	X Walk 1 X Slope (%)	1.5		X Walk 2 X Slope (%)	4.6

N/A	Ramp inside XWalk1?	N/A	N/A	Ramp inside XWalk2?	N/A
	Road Slope (%)	0.4	N/A	Clear Space?	N/A
	Road X Slope (%)	1.5	N/A	Clear Space to XWalk (in)	N/A
N/A	Any Obstructions?	N/A	N/A	Storm Grate/Utility Hazard?	N/A
	Obstruction Type			Storm Grate/Utility Type	
		N/A			N/A
			Yes	Surface Condition? (G/P)	Good

Remove & Replace Curb Ramp With Two New Directional Ramps or Equivalent.

Total Cost: \$ 3200.00
