Access Compliance Report

Public Rights-of-Way

(Curb Ramps)

Intersection ID: 17742	Main Street: S_WENDOVER_RD	Cross Street: PROVIDENCE_RD	Location: NE
ADA ID: 4A0AAF17CD3F	Ramp Type: PerpDiag	Initial Pass/Fail: Fail	Overall Compliance: No
Severity Score: 21.25			
Codes/Mitigation Info/Possible Solution		Field Measurements/Component Compliance

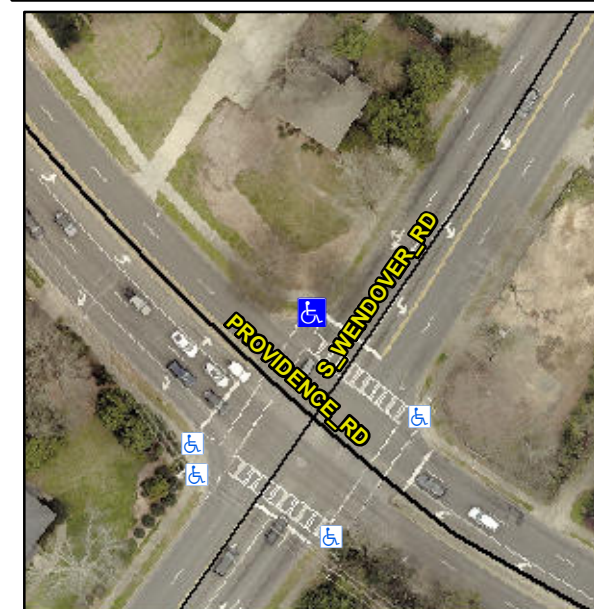
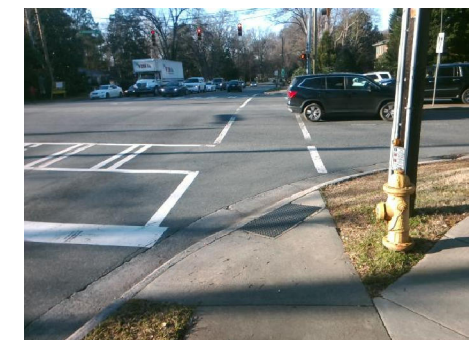
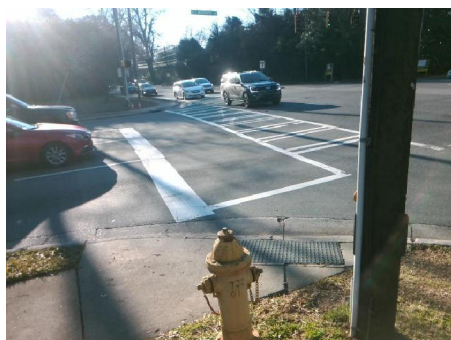
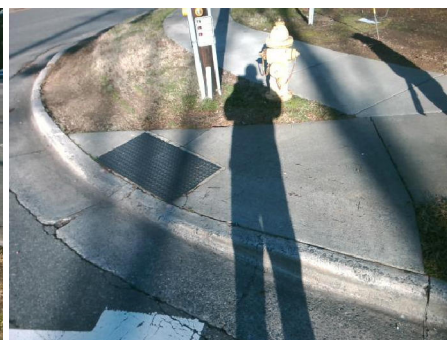
Not Found, R304.5.1, R304.2.2

Compliance	Description	Data	Compliance	Description	Data
N/A	Ramp Length (in)	47.0	No	Ramp Slope (%)	11.7
No	Ramp Width (in)	42.0	Yes	Ramp XSlope (%)	0.9
N/A	Flare Type LT	N/A	N/A	Flare Type RT	N/A
N/A	Flare Slope LT (%)	N/A	N/A	Flare Slope RT (%)	N/A
N/A	Flare Traversable LT?	N/A	N/A	Flare Traversable RT?	N/A
N/A	Landing Length (in)	N/A	N/A	DWS Provided?	N/A
N/A	Landing Width (in)	N/A	N/A	DWS Contrast?	N/A
N/A	Landing Slope (%)	N/A	N/A	DWS Length (in)	N/A
N/A	Landing X Slope (%)	N/A	N/A	DWS Full Width?	N/A
N/A	Landing Curb? (Y/N)	N/A	N/A	DWS Offset (in)	N/A
N/A	Shared Landing?	N/A			
N/A	Gutter Ponding?	N/A	N/A	Gutter Slope (%)	N/A
N/A	Gutter Lip Ht (in)	N/A	N/A	Gutter X Slope (%)	N/A
N/A	Painted X Walk1?	Yes	N/A	Painted X Walk2?	Yes
	X Walk 1 Direction	To SW		X Walk 2 Direction	To SE
N/A	X Walk 1 Width (in)	103.0	N/A	X Walk 2 Width (in)	102.0
	X Walk 1 Slope (%)	0.1		X Walk 2 Slope (%)	4.2
	X Walk 1 X Slope (%)	2.3		X Walk 2 X Slope (%)	0.6

N/A	Ramp inside XWalk1?	Yes	N/A	Ramp inside XWalk2?	No
	Road Slope (%)	1.6	N/A	Clear Space?	N/A
	Road X Slope (%)	1.1	N/A	Clear Space to XWalk (in)	N/A
N/A	Any Obstructions?	N/A	N/A	Storm Grate/Utility Hazard?	N/A
	Obstruction Type			Storm Grate/Utility Type	
		N/A			N/A
		Yes		Surface Condition? (G/P)	Good

Remove & Replace Curb Ramp With Two New Directional Ramps or Equivalent. Restripe Crosswalk.
