# Access Compliance Report

## Public Rights-of-Way

### (Curb Ramps)

| Intersection ID: 10022823 | Main Street: CASTLE_WATCH_AV | Cross Street: N/A | Location: SW |

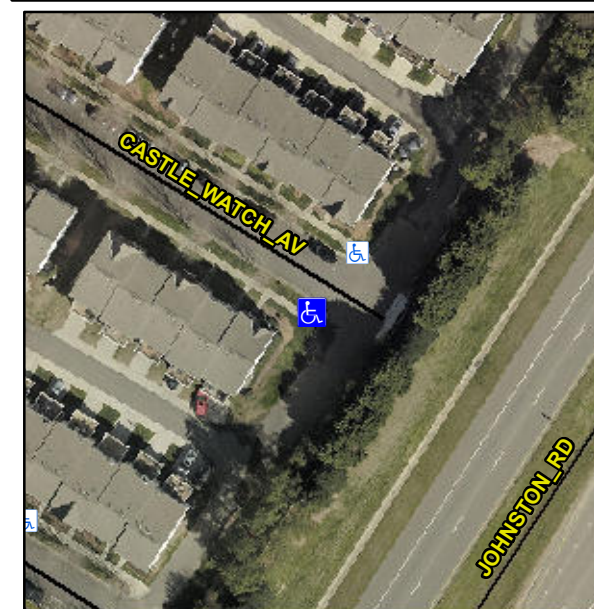
| ADA ID: 4A0ADAF0E5CA | Ramp Type: PerpDiag | Initial Pass/Fail: Fail | Overall Compliance: No |
| Severity Score: 22.5 | | | |

**R304.5.1, R304.2.2, R304.5.3**

| Compliance | Description | Data | Compliance | Description | Data |
|---|---|---|---|---|---|
| N/A | Ramp Length (in) | 78.0 | No | Ramp Slope (%) | 9.5 |
| No | Ramp Width (in) | 46.5 | No | Ramp XSlope (%) | 2.6 |

**Remove & Replace Curb Ramp With Two New Directional Ramps or Equivalent.**

Total Cost: \$ 3200.00
