# Access Compliance Report

## Public Rights-of-Way

### (Curb Ramps)

| Intersection ID: 51586 | Main Street: SHAFTESBURY_RD | Cross Street: ALDEN_OAKS_DR | Location: S |

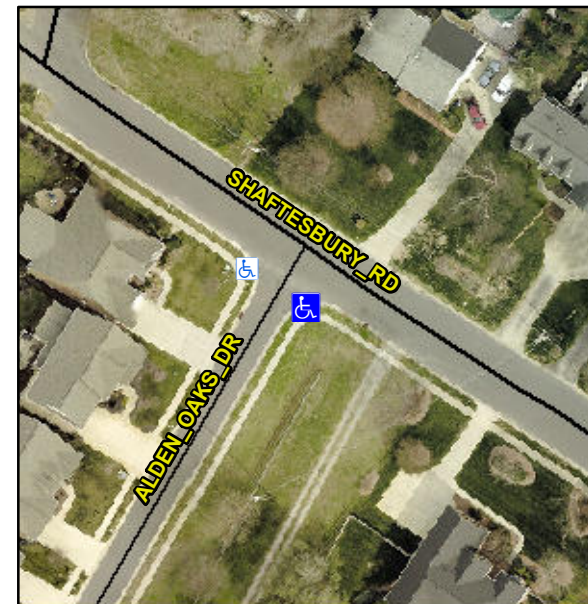
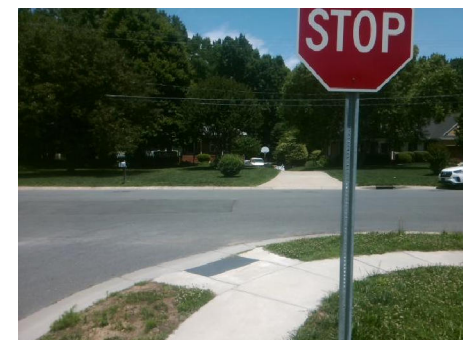
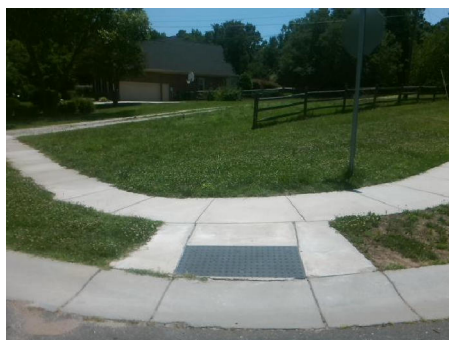
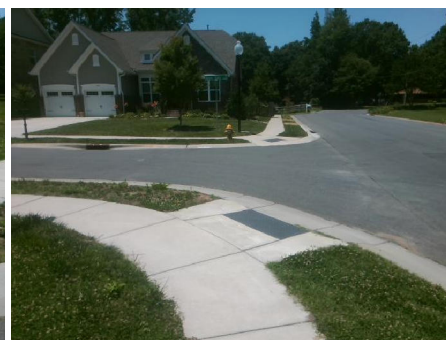
| ADA ID: 4A144E4A03CD | Ramp Type: Perp | Initial Pass/Fail: Fail | Overall Compliance: No |

| Severity Score: 12.5 | | | |

**R304.5.3**

| Compliance | Description | Data | Compliance | Description | Data |
|---|---|---|---|---|---|
| Yes | Ramp Width (in) | 48.0 | No | Ramp XSlope (%) | 5.1 |

**Remove & Replace Entire Ramp.**

Total Cost: \$ **1850.00**
