Intersection ID: 29731	Main Street: HARNEY_DR	Cross Street: RUSHMORE_DR	Location:	S
ADA ID: 4A147182FD03	Ramp Type: PerpDiag	Initial Pass/Fail: Fail	Overall Compliance: No	Severity Score: 21.25

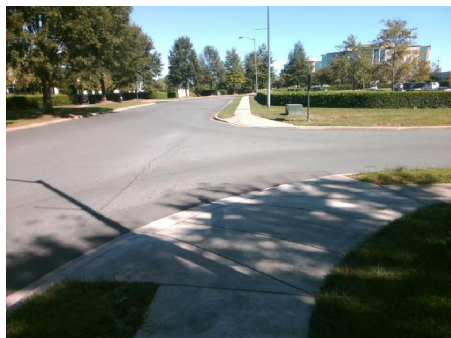
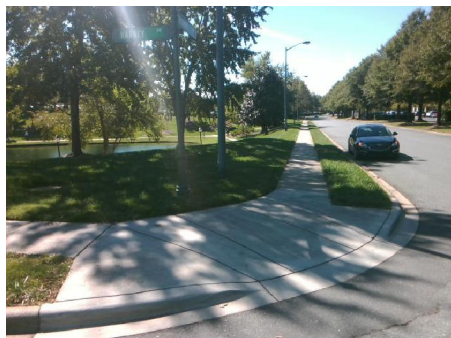
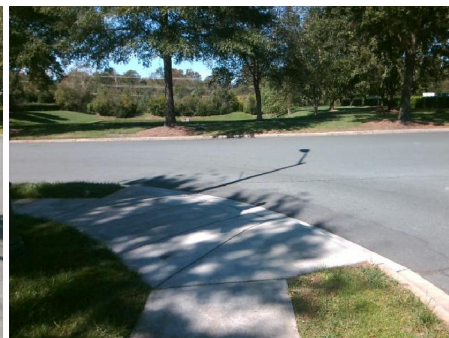
Possible Solutions:		Compliance	Description	Data	Compliance	Description	Data
	Remove & Replace Curb Ramp With Two New Directional Ramps or Equivalent.		N/A	Ramp Length (in)	105.0	No	Ramp Slope (%)	11.2
			No	Ramp Width (in)	46.0	Yes	Ramp XSlope (%)	0.6
			N/A	Flare Type LT	N/A	N/A	Flare Type RT	N/A
			N/A	Flare Slope LT (%)	N/A	N/A	Flare Slope RT (%)	N/A
			N/A	Flare Traversable LT?	N/A	N/A	Flare Traversable RT?	N/A
			N/A	Landing Length (in)	N/A	N/A	DWS Provided?	N/A
			N/A	Landing Width (in)	N/A	N/A	DWS Contrast?	N/A
			N/A	Landing Slope (%)	N/A	N/A	DWS Length (in)	N/A
			N/A	Landing X Slope (%)	N/A	N/A	DWS Full Width?	N/A
Surveyor Notes:		N/A	N/A	Landing Curb? (Y/N)	N/A	N/A	DWS Offset (in)	N/A
PROW/ADA:			N/A	Shared Landing?	N/A			
Not Found, R304.5.1, R304.2.2			N/A	Gutter Ponding?	N/A	N/A	Gutter Slope (%)	N/A

N/A	Gutter Lip Ht (in)	N/A	N/A	Gutter X Slope (%)	N/A
			N/A	Painted X Walk1?	No	N/A	Painted X Walk2?	No
				X Walk 1 Direction	To NE		X Walk 2 Direction	To NW
			N/A	X Walk 1 Width (in)	N/A	N/A	X Walk 2 Width (in)	N/A
				X Walk 1 Slope (%)	3.3		X Walk 2 Slope (%)	1.3
				X Walk 1 X Slope (%)	1.0		X Walk 2 X Slope (%)	2.7
			N/A	Ramp inside XWalk1?	N/A	N/A	Ramp inside XWalk2?	N/A
				Road Slope (%)	0.2	N/A	Clear Space?	N/A
				Road X Slope (%)	5.5	N/A	Clear Space to XWalk (in)	N/A
			N/A	Any Obstructions?	N/A	N/A	Storm Grate/Utility Hazard?	N/A
				Obstruction Type			Storm Grate/Utility Type	
					N/A			N/A
						Yes	Surface Condition? (G/P)	Good
Total Cost:		\$	3200.00
