Access Compliance Report

Public Rights-of-Way

(Curb Ramps)

Intersection ID: 10039791	Main Street: TOLLESON_AV	Cross Street: N/A	Location: SW
ADA ID: 4A1B5A1018D6	Ramp Type: PerpDiag	Initial Pass/Fail: Fail	Overall Compliance: No
Severity Score: 12.5			
Codes/Mitigation Info/Possible Solution		Field Measurements/Component Compliance

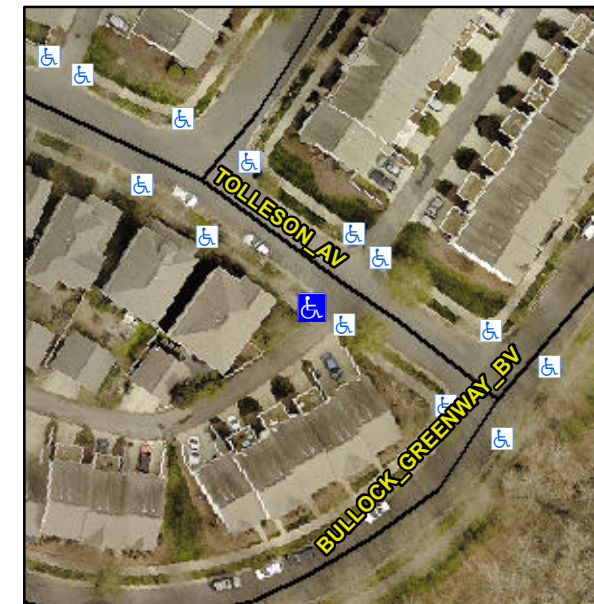
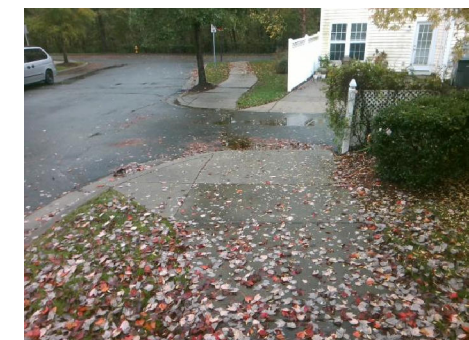
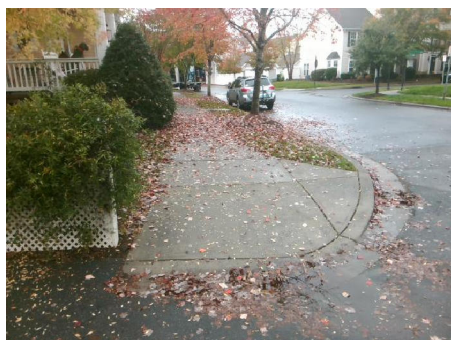
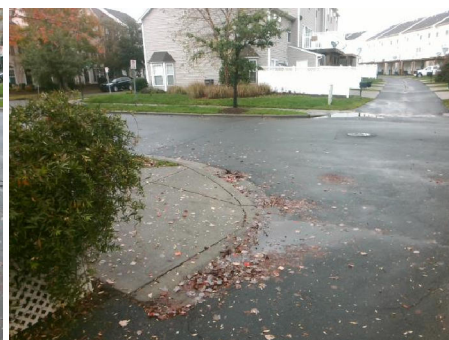
Not Found, R304.2.2

Compliance	Description	Data	Compliance	Description	Data
N/A	Ramp Length (in)	81.0	No	Ramp Slope (%)	8.7
Yes	Ramp Width (in)	87.0	Yes	Ramp XSlope (%)	1.6
N/A	Flare Type LT	N/A	N/A	Flare Type RT	N/A
N/A	Flare Slope LT (%)	N/A	N/A	Flare Slope RT (%)	N/A
N/A	Flare Traversable LT?	N/A	N/A	Flare Traversable RT?	N/A
N/A	Landing Length (in)	N/A	N/A	DWS Provided?	N/A
N/A	Landing Width (in)	N/A	N/A	DWS Contrast?	N/A
N/A	Landing Slope (%)	N/A	N/A	DWS Length (in)	N/A
N/A	Landing X Slope (%)	N/A	N/A	DWS Full Width?	N/A
N/A	Landing Curb? (Y/N)	N/A	N/A	DWS Offset (in)	N/A
N/A	Shared Landing?	N/A			
N/A	Gutter Ponding?	N/A	N/A	Gutter Slope (%)	N/A
N/A	Gutter Lip Ht (in)	N/A	N/A	Gutter X Slope (%)	N/A
N/A	Painted X Walk1?	No	N/A	Painted X Walk2?	No
	X Walk 1 Direction	To SE		X Walk 2 Direction	To NE
N/A	X Walk 1 Width (in)	N/A	N/A	X Walk 2 Width (in)	N/A
	X Walk 1 Slope (%)	2.3		X Walk 2 Slope (%)	0.5
	X Walk 1 X Slope (%)	1.4		X Walk 2 X Slope (%)	1.5

N/A	Ramp inside XWalk1?	N/A	N/A	Ramp inside XWalk2?	N/A
	Road Slope (%)	1.5	N/A	Clear Space?	N/A
	Road X Slope (%)	2.1	N/A	Clear Space to XWalk (in)	N/A
N/A	Any Obstructions?	N/A	N/A	Storm Grate/Utility Hazard?	N/A
	Obstruction Type			Storm Grate/Utility Type	
		N/A			N/A
			Yes	Surface Condition? (G/P)	Good

Remove & Replace Curb Ramp With Two New Directional Ramps or Equivalent.

Total Cost: \$ 3200.00
