Access Compliance Report

Public Rights-of-Way

(Curb Ramps)

Intersection ID: 27440	Main Street: BALLANTYNE_COMMONS_PY	Cross Street: DOWINGTON_DR	Location: NW
ADA ID: 4A1F7E57E926	Ramp Type: Perp	Initial Pass/Fail: Fail	Overall Compliance: No
Severity Score: 10			
Codes/Mitigation Info/Possible Solution		Field Measurements/Component Compliance

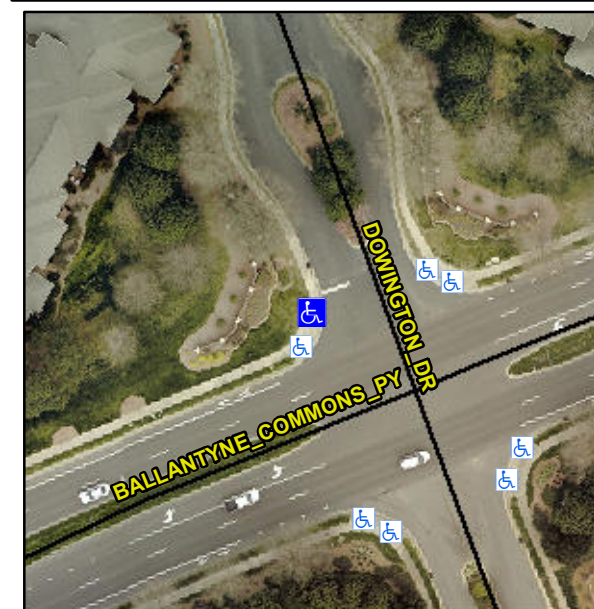
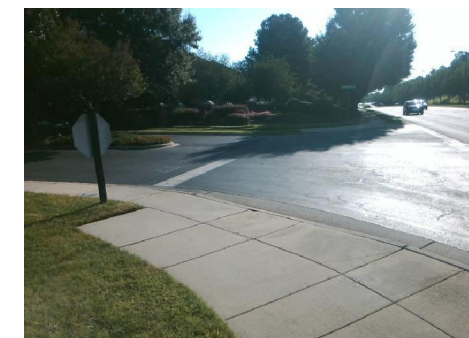
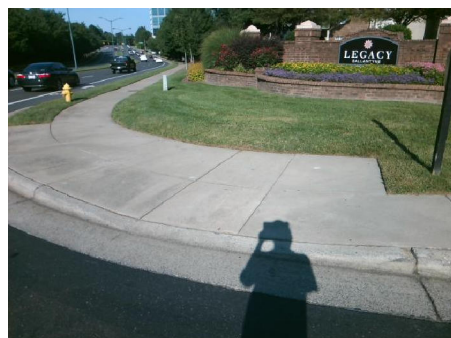
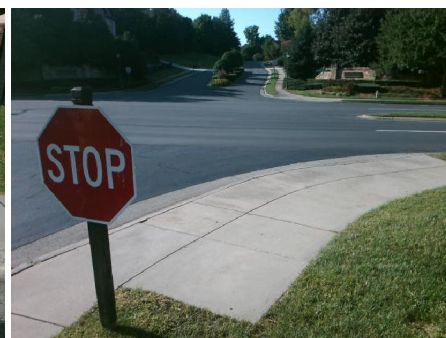
Not Found, R304.5.1, R304.5.3

Compliance	Description	Data	Compliance	Description	Data
N/A	Ramp Length (in)	108.0	Yes	Ramp Slope (%)	7.8
No	Ramp Width (in)	38.0	No	Ramp XSlope (%)	3.5
N/A	Flare Type LT	N/A	N/A	Flare Type RT	N/A
N/A	Flare Slope LT (%)	N/A	N/A	Flare Slope RT (%)	N/A
N/A	Flare Traversable LT?	N/A	N/A	Flare Traversable RT?	N/A
N/A	Landing Length (in)	N/A	N/A	DWS Provided?	N/A
N/A	Landing Width (in)	N/A	N/A	DWS Contrast?	N/A
N/A	Landing Slope (%)	N/A	N/A	DWS Length (in)	N/A
N/A	Landing X Slope (%)	N/A	N/A	DWS Full Width?	N/A
N/A	Landing Curb? (Y/N)	N/A	N/A	DWS Offset (in)	N/A
N/A	Shared Landing?	N/A			
N/A	Gutter Ponding?	N/A	N/A	Gutter Slope (%)	N/A
N/A	Gutter Lip Ht (in)	N/A	N/A	Gutter X Slope (%)	N/A
N/A	Painted X Walk1?	No	N/A	Painted X Walk2?	N/A
	X Walk 1 Direction	To NE		X Walk 2 Direction	N/A
N/A	X Walk 1 Width (in)	N/A	N/A	X Walk 2 Width (in)	N/A
	X Walk 1 Slope (%)	1.5		X Walk 2 Slope (%)	N/A
	X Walk 1 X Slope (%)	2.7		X Walk 2 X Slope (%)	N/A

N/A	Ramp inside XWalk1?	N/A	N/A	Ramp inside XWalk2?	N/A
	Road Slope (%)	N/A	N/A	Clear Space?	N/A
	Road X Slope (%)	N/A	N/A	Clear Space to XWalk (in)	N/A
N/A	Any Obstructions?	N/A	N/A	Storm Grate/Utility Hazard?	N/A
	Obstruction Type			Storm Grate/Utility Type	
		N/A			N/A
			Yes	Surface Condition? (G/P)	Good

Possible Solutions:

Remove & Replace Entire Ramp.
