Access Compliance Report

Public Rights-of-Way

(Curb Ramps)

Intersection ID: 46788	Main Street: STOWE_ACRES_DR	Cross Street: ALMOND_HILLS_DR	Location: SE
ADA ID: 4A2C83D97E23	Ramp Type: PerpDiag	Initial Pass/Fail: Fail	Overall Compliance: No
Severity Score: 22.5			
Codes/Mitigation Info/Possible Solution		Field Measurements/Component Compliance

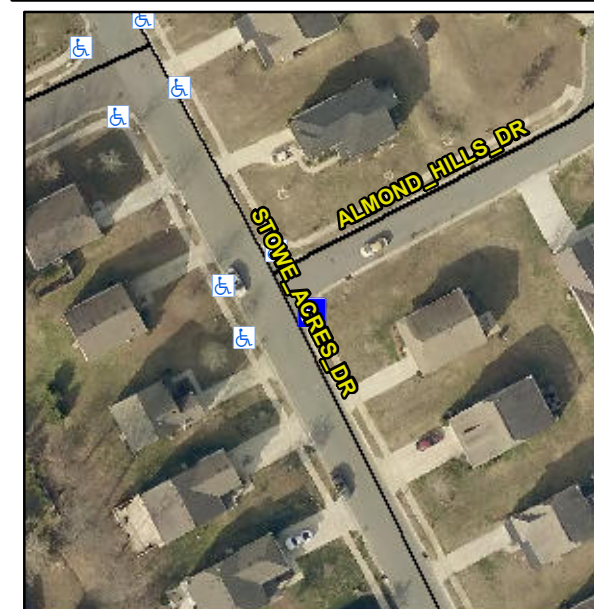
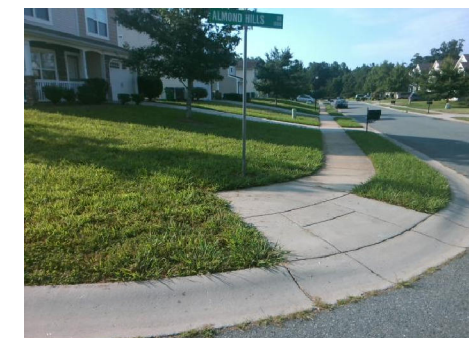
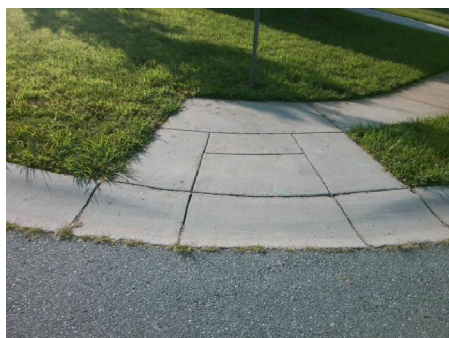
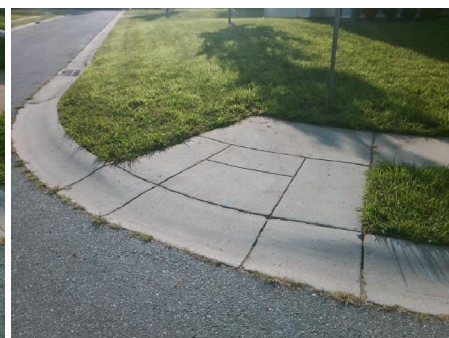
Not Found, R304.5.1, R304.2.2, R304.5.3

Compliance	Description	Data	Compliance	Description	Data
N/A	Ramp Length (in)	46.5	No	Ramp Slope (%)	9.0
No	Ramp Width (in)	36.0	No	Ramp XSlope (%)	3.2
N/A	Flare Type LT	N/A	N/A	Flare Type RT	N/A
N/A	Flare Slope LT (%)	N/A	N/A	Flare Slope RT (%)	N/A
N/A	Flare Traversable LT?	N/A	N/A	Flare Traversable RT?	N/A
N/A	Landing Length (in)	N/A	N/A	DWS Provided?	N/A
N/A	Landing Width (in)	N/A	N/A	DWS Contrast?	N/A
N/A	Landing Slope (%)	N/A	N/A	DWS Length (in)	N/A
N/A	Landing X Slope (%)	N/A	N/A	DWS Full Width?	N/A
N/A	Landing Curb? (Y/N)	N/A	N/A	DWS Offset (in)	N/A
N/A	Shared Landing?	N/A			
N/A	Gutter Ponding?	N/A	N/A	Gutter Slope (%)	N/A
N/A	Gutter Lip Ht (in)	N/A	N/A	Gutter X Slope (%)	N/A
N/A	Painted X Walk1?	No	N/A	Painted X Walk2?	No
	X Walk 1 Direction	To N		X Walk 2 Direction	To W
N/A	X Walk 1 Width (in)	N/A	N/A	X Walk 2 Width (in)	N/A
	X Walk 1 Slope (%)	3.2		X Walk 2 Slope (%)	0.4
	X Walk 1 X Slope (%)	1.2		X Walk 2 X Slope (%)	2.6

N/A	Ramp inside XWalk1?	N/A	N/A	Ramp inside XWalk2?	N/A
	Road Slope (%)	3.0	N/A	Clear Space?	N/A
	Road X Slope (%)	4.2	N/A	Clear Space to XWalk (in)	N/A
N/A	Any Obstructions?	N/A	N/A	Storm Grate/Utility Hazard?	N/A
	Obstruction Type			Storm Grate/Utility Type	
		N/A			N/A
			Yes	Surface Condition? (G/P)	Good

Remove & Replace Curb Ramp With Two New Directional Ramps or Equivalent.
