Access Compliance Report

Public Rights-of-Way

(Curb Ramps)

Intersection ID: 44699	Main Street: STILLGREEN_LN	Cross Street: BIRCHWOOD_DR	Location:	N
ADA ID: 4A306ECF75DC	Ramp Type: Perp	Initial Pass/Fail: Fail	Overall Compliance: No	Severity Score: 35

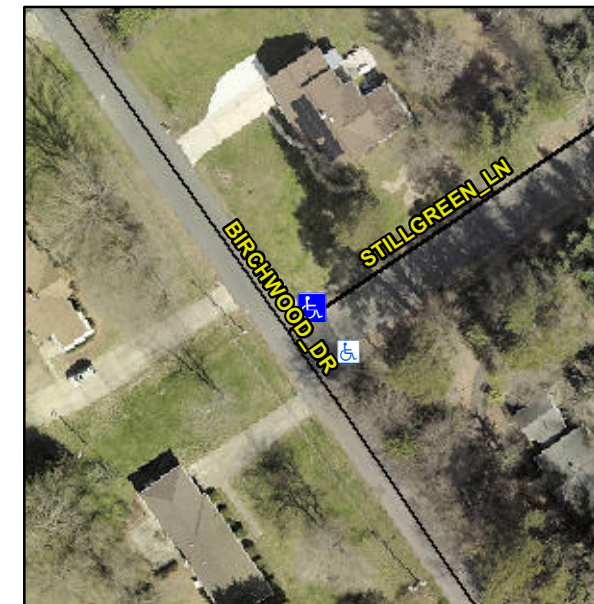
Not Found, R304.5.1

Compliance	Description	Data	Compliance	Description	Data
N/A	Ramp Length (in)	45.0	Yes	Ramp Slope (%)	5.8
No	Ramp Width (in)	30.5	Yes	Ramp XSlope (%)	0.8
N/A	Flare Type LT	N/A	N/A	Flare Type RT	N/A
N/A	Flare Slope LT (%)	N/A	N/A	Flare Slope RT (%)	N/A
N/A	Flare Traversable LT?	N/A	N/A	Flare Traversable RT?	N/A
N/A	Landing Length (in)	N/A	N/A	DWS Provided?	N/A
N/A	Landing Width (in)	N/A	N/A	DWS Contrast?	N/A
N/A	Landing Slope (%)	N/A	N/A	DWS Length (in)	N/A
N/A	Landing X Slope (%)	N/A	N/A	DWS Full Width?	N/A
N/A	Landing Curb? (Y/N)	N/A	N/A	DWS Offset (in)	N/A
N/A	Shared Landing?	N/A			
N/A	Gutter Ponding?	N/A	N/A	Gutter Slope (%)	N/A
N/A	Gutter Lip Ht (in)	N/A	N/A	Gutter X Slope (%)	N/A
N/A	Painted X Walk1?	No	N/A	Painted X Walk2?	N/A
	X Walk 1 Direction	To SE		X Walk 2 Direction	N/A
N/A	X Walk 1 Width (in)	N/A	N/A	X Walk 2 Width (in)	N/A
	X Walk 1 Slope (%)	4.0		X Walk 2 Slope (%)	N/A
	X Walk 1 X Slope (%)	1.2		X Walk 2 X Slope (%)	N/A

N/A	Ramp inside XWalk1?	N/A	N/A	Ramp inside XWalk2?	N/A
	Road Slope (%)	N/A	N/A	Clear Space?	N/A
	Road X Slope (%)	N/A	N/A	Clear Space to XWalk (in)	N/A
N/A	Any Obstructions?	N/A	N/A	Storm Grate/Utility Hazard?	N/A
	Obstruction Type			Storm Grate/Utility Type	
		N/A			N/A
			Yes	Surface Condition? (G/P)	Good

Remove & Replace Entire Ramp.
