Access Compliance Report

Public Rights-of-Way

(Curb Ramps)

Intersection ID: 14069	Main Street: CLARICE_AV	Cross Street: E_8TH_ST	Location: S
ADA ID: 4A42E0EA5C19	Ramp Type: PerpDiag	Initial Pass/Fail: Fail	Overall Compliance: No
Severity Score: 13.75			
Codes/Mitigation Info/Possible Solution		Field Measurements/Component Compliance

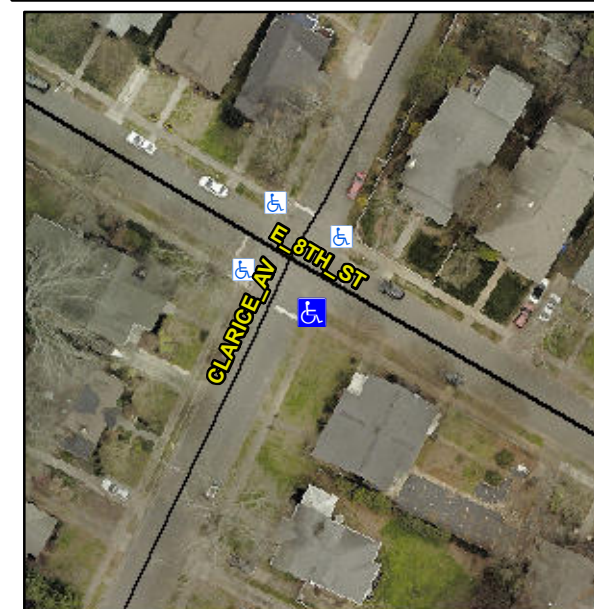
Compliance	Description	Data	Compliance	Description	Data
N/A	Ramp Length (in)	112.0	No	Ramp Slope (%)	8.4
Yes	Ramp Width (in)	48.0	No	Ramp XSlope (%)	4.6
N/A	Flare Type LT	N/A	N/A	Flare Type RT	N/A
N/A	Flare Slope LT (%)	N/A	N/A	Flare Slope RT (%)	N/A
N/A	Flare Traversable LT?	N/A	N/A	Flare Traversable RT?	N/A
N/A	Landing Length (in)	N/A	N/A	DWS Provided?	N/A
N/A	Landing Width (in)	N/A	N/A	DWS Contrast?	N/A
N/A	Landing Slope (%)	N/A	N/A	DWS Length (in)	N/A
N/A	Landing X Slope (%)	N/A	N/A	DWS Full Width?	N/A
N/A	Landing Curb? (Y/N)	N/A	N/A	DWS Offset (in)	N/A
N/A	Shared Landing?	N/A			
N/A	Gutter Ponding?	N/A	N/A	Gutter Slope (%)	N/A
N/A	Gutter Lip Ht (in)	N/A	N/A	Gutter X Slope (%)	N/A
N/A	Painted X Walk1?	No	N/A	Painted X Walk2?	No
	X Walk 1 Direction	To NE		X Walk 2 Direction	To NW
N/A	X Walk 1 Width (in)	N/A	N/A	X Walk 2 Width (in)	N/A
	X Walk 1 Slope (%)	0.2		X Walk 2 Slope (%)	2.2
	X Walk 1 X Slope (%)	0.2		X Walk 2 X Slope (%)	3.5

N/A	Ramp inside XWalk1?	N/A	N/A	Ramp inside XWalk2?	N/A
	Road Slope (%)	0.3	N/A	Clear Space?	N/A
	Road X Slope (%)	0.2	N/A	Clear Space to XWalk (in)	N/A
N/A	Any Obstructions?	N/A	N/A	Storm Grate/Utility Hazard?	N/A
	Obstruction Type			Storm Grate/Utility Type	
		N/A			N/A
		Yes		Surface Condition? (G/P)	Good

Possible Solutions:

Remove & Replace Curb Ramp With Two New Directional Ramps or Equivalent.
