Access Compliance Report

Public Rights-of-Way

(Curb Ramps)

Intersection ID: 27051	Main Street: GOSFORD_PL	Cross Street: SETON_HOUSE_LN	Location:	N
ADA ID: 4A47F3BB5888	Ramp Type: Perp	Initial Pass/Fail: Fail	Overall Compliance: No	Severity Score: 22.5

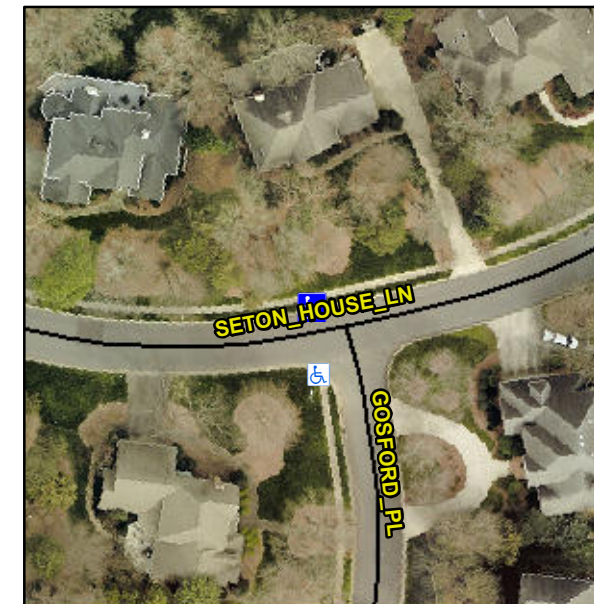
Not Found, R304.5.1, R304.2.2, R304.5.3

Compliance	Description	Data	Compliance	Description	Data
N/A	Ramp Length (in)	94.0	No	Ramp Slope (%)	8.4
No	Ramp Width (in)	46.5	No	Ramp XSlope (%)	4.2
N/A	Flare Type LT	N/A	N/A	Flare Type RT	N/A
N/A	Flare Slope LT (%)	N/A	N/A	Flare Slope RT (%)	N/A
N/A	Flare Traversable LT?	N/A	N/A	Flare Traversable RT?	N/A
N/A	Landing Length (in)	N/A	N/A	DWS Provided?	N/A
N/A	Landing Width (in)	N/A	N/A	DWS Contrast?	N/A
N/A	Landing Slope (%)	N/A	N/A	DWS Length (in)	N/A
N/A	Landing X Slope (%)	N/A	N/A	DWS Full Width?	N/A
N/A	Landing Curb? (Y/N)	N/A	N/A	DWS Offset (in)	N/A
N/A	Shared Landing?	N/A			
N/A	Gutter Ponding?	N/A	N/A	Gutter Slope (%)	N/A
N/A	Gutter Lip Ht (in)	N/A	N/A	Gutter X Slope (%)	N/A
N/A	Painted X Walk1?	No	N/A	Painted X Walk2?	N/A
	X Walk 1 Direction	To S		X Walk 2 Direction	N/A
N/A	X Walk 1 Width (in)	N/A	N/A	X Walk 2 Width (in)	N/A
	X Walk 1 Slope (%)	3.8		X Walk 2 Slope (%)	N/A
	X Walk 1 X Slope (%)	4.1		X Walk 2 X Slope (%)	N/A

N/A	Ramp inside XWalk1?	N/A	N/A	Ramp inside XWalk2?	N/A
	Road Slope (%)	N/A	N/A	Clear Space?	N/A
	Road X Slope (%)	N/A	N/A	Clear Space to XWalk (in)	N/A
N/A	Any Obstructions?	N/A	N/A	Storm Grate/Utility Hazard?	N/A
	Obstruction Type			Storm Grate/Utility Type	
		N/A			N/A
			Yes	Surface Condition? (G/P)	Good

Remove & Replace Entire Ramp.
