Access Compliance Report

Public Rights-of-Way

(Curb Ramps)

Intersection ID: 17032	Main Street: QUEENS_RD_WEST	Cross Street: WESTFIELD_RD	Location: W
ADA ID: 4A49C9D0F895	Ramp Type: Perp	Initial Pass/Fail: Fail	Overall Compliance: No
Severity Score: 37.5			
Codes/Mitigation Info/Possible Solution		Field Measurements/Component Compliance

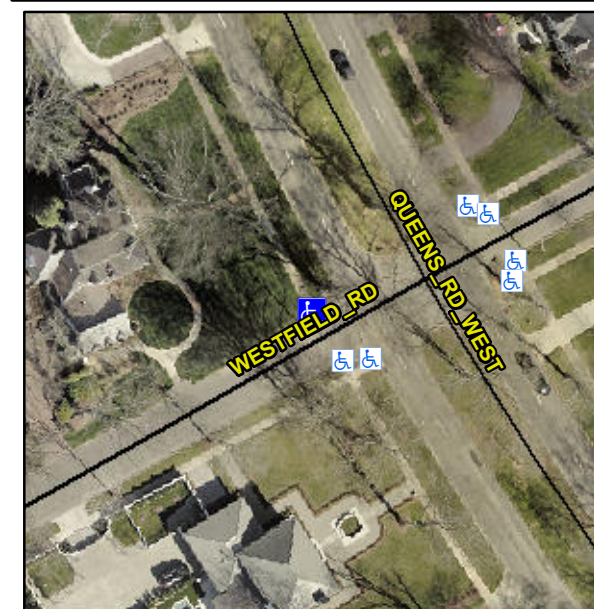
Not Found, R304.2.2, R304.5.3

Compliance	Description	Data	Compliance	Description	Data
N/A	Ramp Length (in)	85.0	No	Ramp Slope (%)	11.3
Yes	Ramp Width (in)	48.0	No	Ramp XSlope (%)	11.9
N/A	Flare Type LT	N/A	N/A	Flare Type RT	N/A
N/A	Flare Slope LT (%)	N/A	N/A	Flare Slope RT (%)	N/A
N/A	Flare Traversable LT?	N/A	N/A	Flare Traversable RT?	N/A
N/A	Landing Length (in)	N/A	N/A	DWS Provided?	N/A
N/A	Landing Width (in)	N/A	N/A	DWS Contrast?	N/A
N/A	Landing Slope (%)	N/A	N/A	DWS Length (in)	N/A
N/A	Landing X Slope (%)	N/A	N/A	DWS Full Width?	N/A
N/A	Landing Curb? (Y/N)	N/A	N/A	DWS Offset (in)	N/A
N/A	Shared Landing?	N/A			
N/A	Gutter Ponding?	Yes	N/A	Gutter Slope (%)	N/A
N/A	Gutter Lip Ht (in)	N/A	N/A	Gutter X Slope (%)	N/A
N/A	Painted X Walk1?	No	N/A	Painted X Walk2?	N/A
	X Walk 1 Direction	To SE		X Walk 2 Direction	N/A
N/A	X Walk 1 Width (in)	N/A	N/A	X Walk 2 Width (in)	N/A
	X Walk 1 Slope (%)	2.6		X Walk 2 Slope (%)	N/A
	X Walk 1 X Slope (%)	2.3		X Walk 2 X Slope (%)	N/A

N/A	Ramp inside XWalk1?	N/A	N/A	Ramp inside XWalk2?	N/A
	Road Slope (%)	N/A	N/A	Clear Space?	N/A
	Road X Slope (%)	N/A	N/A	Clear Space to XWalk (in)	N/A
N/A	Any Obstructions?	N/A	N/A	Storm Grate/Utility Hazard?	N/A
	Obstruction Type			Storm Grate/Utility Type	
		N/A			N/A
		Yes		Surface Condition? (G/P)	Good

Possible Solutions:

Remove & Replace Entire Ramp.
