# Access Compliance Report

## Public Rights-of-Way

### (Curb Ramps)

Intersection ID: 10878	Main Street: SPRATT_ST	Cross Street: N/A	Location: NE
ADA ID: 4A514F44FA7E	Ramp Type: Perp	Initial Pass/Fail: Pass	Overall Compliance: No
Severity Score: 20.25			
Codes/Mitigation Info/Possible Solution		Field Measurements/Component Compliance

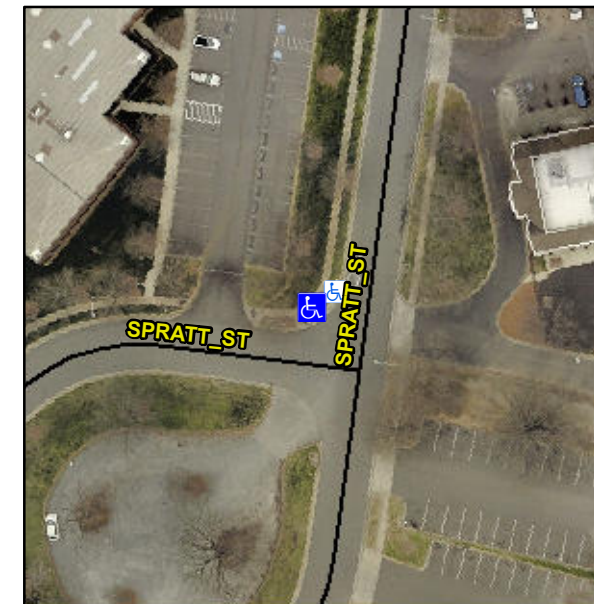
Compliance	Description	Data	Compliance	Description	Data
N/A	Ramp Length (in)	67.0	Yes	Ramp Slope (%)	5.2
Yes	Ramp Width (in)	50.0	Yes	Ramp XSlope (%)	3.0
N/A	Flare Type LT	Sloped	N/A	Flare Type RT	N/A
N/A	Flare Slope LT (%)	9.4	No	Flare Slope RT (%)	10.1
N/A	Flare Traversable LT?	Yes	N/A	Flare Traversable RT?	Yes
No	Landing Length (in)	30.0	Yes	DWS Provided?	Yes
Yes	Landing Width (in)	52.5	Yes	DWS Contrast?	Yes
Yes	Landing Slope (%)	1.5	Yes	DWS Length (in)	25.5
No	Landing X Slope (%)	5.3	No	DWS Full Width?	No
N/A	Landing Curb? (Y/N)	No	No	DWS Offset (in)	3.5
N/A	Shared Landing?	No			
No	Gutter Ponding?	Yes	Yes	Gutter Slope (%)	3.7
No	Gutter Lip Ht (in)	1.5	Yes	Gutter X Slope (%)	0.9
N/A	Painted X Walk1?	No	N/A	Painted X Walk2?	N/A
	X Walk 1 Direction	To S		X Walk 2 Direction	N/A
N/A	X Walk 1 Width (in)	N/A	N/A	X Walk 2 Width (in)	N/A
	X Walk 1 Slope (%)	2.2		X Walk 2 Slope (%)	N/A
	X Walk 1 X Slope (%)	5.0		X Walk 2 X Slope (%)	N/A

N/A	Ramp inside XWalk1?	N/A	N/A	Ramp inside XWalk2?	N/A
	Road Slope (%)	N/A	N/A	Clear Space?	Yes
	Road X Slope (%)	N/A	N/A	Clear Space to XWalk (in)	N/A
Yes	Any Obstructions?	No	Yes	Storm Grate/Utility Hazard?	No
	Obstruction Type			Storm Grate/Utility Type	
		N/A			N/A
			Yes	Surface Condition? (G/P)	Good

Possible Solutions:

**Remove & Replace Entire Ramp.**
