## Access Compliance Report Public Rights-of-Way (Curb Ramps)

Intersection ID: 4910Main Street: ALBA\_CTCross Street: GRANARD\_LNLocation:NEADA ID: 4A53E6FA4EF8Ramp Type: PerpInitial Pass/Fail: FailOverall Compliance: NoSeverity Score:50

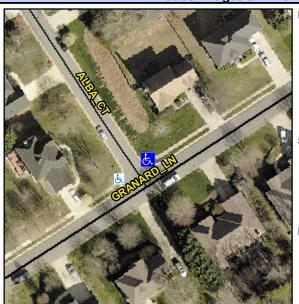
| Possible Solutions: | Co |
|---|---|
| Not Found, R304.2.2, R304.5.3 | N/A |

| Field Measurements/Component Compilance | | | | | | |
|---|---|---|---|---|---|--|
| N/A | Ramp Length (in) | 51.0 | No | Ramp Slope (%) | 13.9 | |
| Yes | Ramp Width (in) | 54.0 | No | Ramp XSlope (%) | 10.2 | |

| Possible Solutions: | Co |
|---|---|
| Remove & Replace Entire Ramp. | N/A |
