Access Compliance Report Public Rights-of-Way (Curb Ramps)

Intersection ID: 7837 Main Street: CORWIN_DR Cross Street: SNOW_WHITE_LN Location: SE

ADA ID: 4A64BF65DF53 Ramp Type: Directional1 Initial Pass/Fail: Fail Overall Compliance: No Severity Score: 21.25

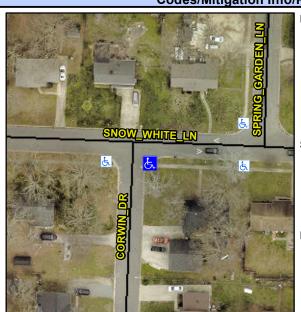
Possible Solution		Field Meas
Possible Solutions:	Comp	liance Description
Remove & Replace Entire Ramp.	N/A	Ramp Length (in)
·	No	Ramp Width (in)
	No	Ramp Slope (%)
	Yes	Ramp XSlope (%)
	N/A	Flare Type LT
	N/A	Flare Slope LT (%)
Surveyor Notes:	N/A	Flare Traversable LT?
WATER VALVE WITH NO COVER	N/A	Landing Length (in)
	N/A	Landing Width (in)
	N/A	Landing Slope (%)
	N/A	Landing X Slope (%)
PROW/ADA:	N/A	Landing Curb? (Y/N)
R304.5.1, R304.2.2	N/A	Shared Landing?
	N/A	Gutter Ponding?
	N/A	Gutter Lip Ht (in)
	N/A	Painted X Walk1?
		X Walk 1 Direction
		X Walk 1 Width (in)
		X Walk 1 Slope (%)
		X Walk 1 X Slope (%)
