Access Compliance Report

Public Rights-of-Way

(Curb Ramps)

Intersection ID: 54460	Main Street: STEELE_MEADOW_RD	Cross Street: FLINT_HILL_DR	Location: NE
ADA ID: 4A6F9A298896	Ramp Type: Perp	Initial Pass/Fail: Fail	Overall Compliance: No
Severity Score: 1.25			
Codes/Mitigation Info/Possible Solution		Field Measurements/Component Compliance

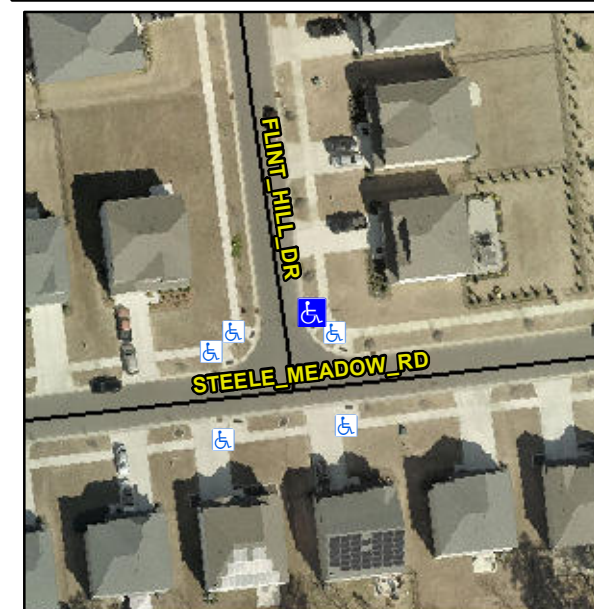
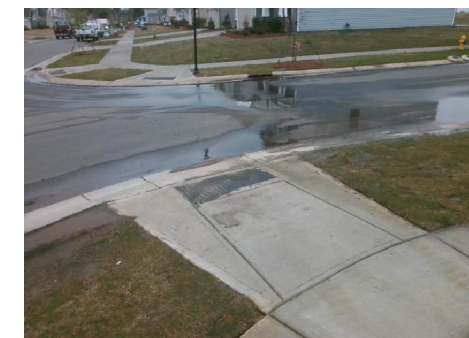
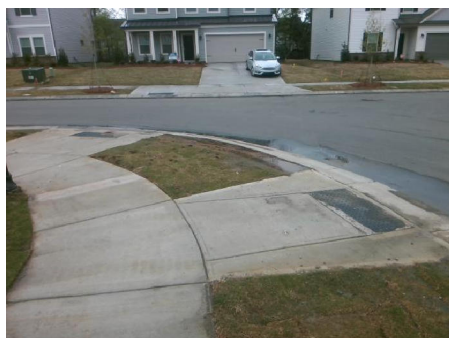
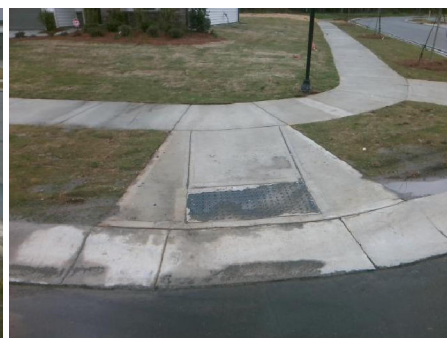
Not Found, R304.5.3

Compliance	Description	Data	Compliance	Description	Data
N/A	Ramp Length (in)	95.0	Yes	Ramp Slope (%)	5.6
Yes	Ramp Width (in)	48.0	No	Ramp XSlope (%)	3.7
N/A	Flare Type LT	N/A	N/A	Flare Type RT	N/A
N/A	Flare Slope LT (%)	N/A	N/A	Flare Slope RT (%)	N/A
N/A	Flare Traversable LT?	N/A	N/A	Flare Traversable RT?	N/A
N/A	Landing Length (in)	N/A	N/A	DWS Provided?	N/A
N/A	Landing Width (in)	N/A	N/A	DWS Contrast?	N/A
N/A	Landing Slope (%)	N/A	N/A	DWS Length (in)	N/A
N/A	Landing X Slope (%)	N/A	N/A	DWS Full Width?	N/A
N/A	Landing Curb? (Y/N)	N/A	N/A	DWS Offset (in)	N/A
N/A	Shared Landing?	N/A			
N/A	Gutter Ponding?	N/A	N/A	Gutter Slope (%)	N/A
N/A	Gutter Lip Ht (in)	N/A	N/A	Gutter X Slope (%)	N/A
N/A	Painted X Walk1?	No	N/A	Painted X Walk2?	N/A
	X Walk 1 Direction	To W		X Walk 2 Direction	N/A
N/A	X Walk 1 Width (in)	N/A	N/A	X Walk 2 Width (in)	N/A
	X Walk 1 Slope (%)	0.4		X Walk 2 Slope (%)	N/A
	X Walk 1 X Slope (%)	1.3		X Walk 2 X Slope (%)	N/A

N/A	Ramp inside XWalk1?	N/A	N/A	Ramp inside XWalk2?	N/A
	Road Slope (%)	N/A	N/A	Clear Space?	N/A
	Road X Slope (%)	N/A	N/A	Clear Space to XWalk (in)	N/A
N/A	Any Obstructions?	N/A	N/A	Storm Grate/Utility Hazard?	N/A
	Obstruction Type			Storm Grate/Utility Type	
		N/A			N/A
		Yes		Surface Condition? (G/P)	Good

Possible Solutions:

Remove & Replace Entire Ramp.
