Access Compliance Report

(Curb Ramps)

Intersection ID: 24400	Main Street: FRESHWELL_RD	Cross Street: POPPLETON_CT	Location: SE
ADA ID: 4A76FF90A615	Ramp Type: PerpDiag	Initial Pass/Fail: Pass	Overall Compliance: No
		Severity Score: 10

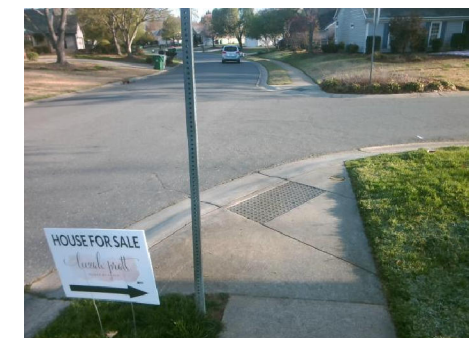
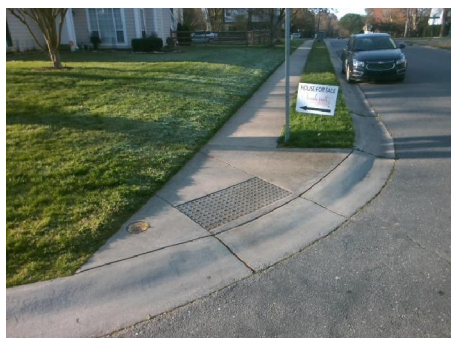
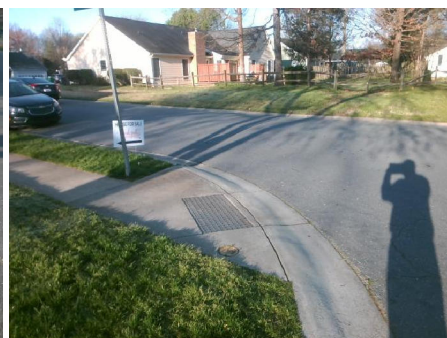
Not Found, R304.2.1, R304.2.2-Perp, R304.3.2-Para, R304.5.3, R305.2

Compliance	Description	Data	Compliance	Description	Data
N/A	Ramp Length (in)	43.0	Yes	Ramp Slope (%)	7.6
Yes	Ramp Width (in)	48.0	Yes	Ramp XSlope (%)	1.8
N/A	Flare Type LT	Sloped	N/A	Flare Type RT	N/A
N/A	Flare Slope LT (%)	1.6	Yes	Flare Slope RT (%)	4.8
N/A	Flare Traversable LT?	No	N/A	Flare Traversable RT?	Yes
No	Landing Length (in)	N/A	Yes	DWS Provided?	Yes
No	Landing Width (in)	N/A	Yes	DWS Contrast?	Yes
No	Landing Slope (%)	N/A	Yes	DWS Length (in)	24.0
No	Landing X Slope (%)	N/A	Yes	DWS Full Width?	Yes
N/A	Landing Curb? (Y/N)	No	No	DWS Offset (in)	5.0
N/A	Shared Landing?	No			
Yes	Gutter Ponding?	No	Yes	Gutter Slope (%)	0.9
Yes	Gutter Lip Ht (in)	0.0	Yes	Gutter X Slope (%)	1.8
N/A	Painted X Walk1?	No	N/A	Painted X Walk2?	No
	X Walk 1 Direction	To N		X Walk 2 Direction	To W
N/A	X Walk 1 Width (in)	N/A	N/A	X Walk 2 Width (in)	N/A
	X Walk 1 Slope (%)	1.9		X Walk 2 Slope (%)	3.4
	X Walk 1 X Slope (%)	0.5		X Walk 2 X Slope (%)	0.3

N/A	Ramp inside XWalk1?	N/A	N/A	Ramp inside XWalk2?	N/A
	Road Slope (%)	1.1	N/A	Clear Space?	Yes
	Road X Slope (%)	2.6	N/A	Clear Space to XWalk (in)	N/A
Yes	Any Obstructions?	No	Yes	Storm Grate/Utility Hazard?	No
	Obstruction Type			Storm Grate/Utility Type	
		N/A			N/A
			Yes	Surface Condition? (G/P)	Good

Remove & Replace Curb Ramp With Two New Directional Ramps or Equivalent.
