# Access Compliance Report

## Public Rights-of-Way

### (Curb Ramps)

Intersection ID: 28112	Main Street: PROVIDENCE_RD	Cross Street: BELICOURT_DR	Location: SW
ADA ID: 4A78F50F5752	Ramp Type: Para	Initial Pass/Fail: Fail	Overall Compliance: No
Codes/Mitigation Info/Possible Solution		Field Measurements/Component Compliance	
Severity Score: 13.75

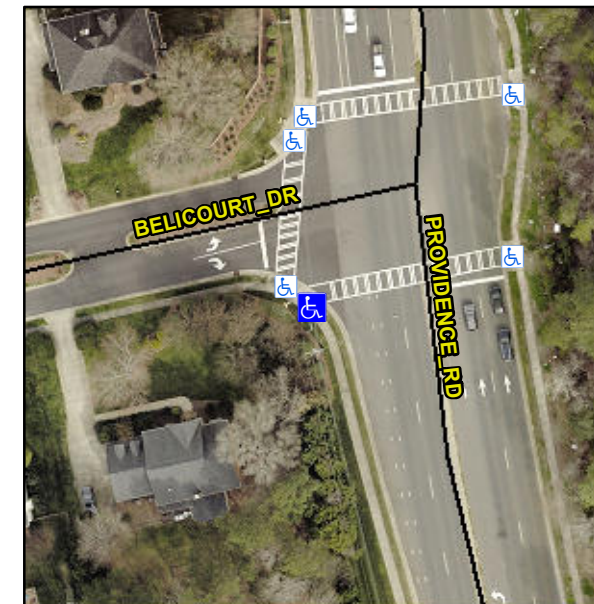
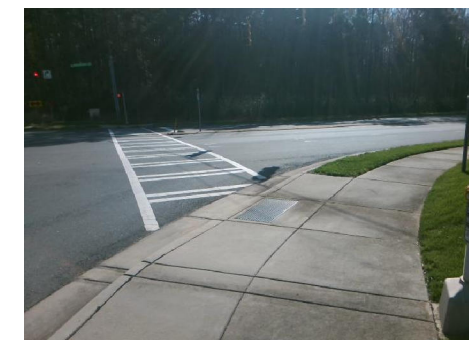
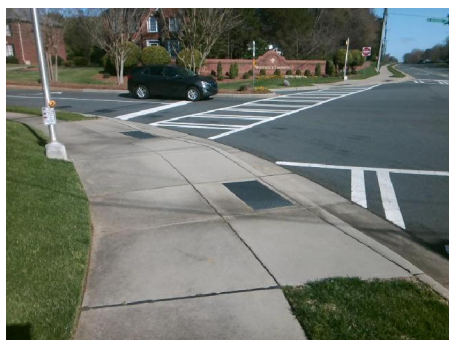
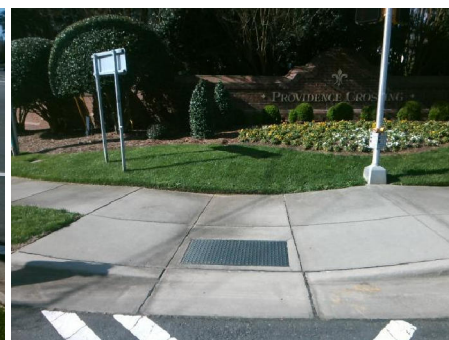
**LT RP < 5%**

**R304.5.3, R304.3.2**

Compliance	Description	Data	Compliance	Description	Data
N/A	Ramp Length LT (in)	56.0	N/A	Ramp Length RT (in)	61.0
Yes	Ramp Width LT (in)	60.0	Yes	Ramp Width RT (in)	60.5
Yes	Ramp Slope LT (%)	4.7	No	Ramp Slope RT (%)	9.2
No	Ramp XSlope LT (%)	2.3	No	Ramp XSlope RT (%)	2.8
N/A	Landing Length (in)	N/A	N/A	DWS Provided?	N/A
N/A	Landing Width (in)	N/A	N/A	DWS Contrast?	N/A
N/A	Landing Slope (%)	N/A	N/A	DWS Length (in)	N/A
N/A	Landing X Slope (%)	N/A	N/A	DWS Full Width?	N/A
N/A	Landing Curb? (Y/N)	N/A	N/A	DWS Offset (in)	N/A
N/A	Shared Landing?	N/A			
N/A	Gutter Ponding?	N/A	N/A	Gutter Slope (%)	N/A
N/A	Gutter Lip Ht (in)	N/A	N/A	Gutter X Slope (%)	N/A
N/A	Painted X Walk1?	Yes	N/A	Painted X Walk2?	N/A
	X Walk 1 Direction	To E		X Walk 2 Direction	N/A
N/A	X Walk 1 Width (in)	106.0	N/A	X Walk 2 Width (in)	N/A
	X Walk 1 Slope (%)	0.0		X Walk 2 Slope (%)	N/A
	X Walk 1 X Slope (%)	3.3		X Walk 2 X Slope (%)	N/A
N/A	Ramp inside XWalk1?	Yes	N/A	Ramp inside XWalk2?	N/A

Road Slope (%)	N/A	N/A	Clear Space?	N/A
	Road X Slope (%)	N/A	N/A	Clear Space to XWalk (in)	N/A
N/A	Any Obstructions?	N/A	N/A	Storm Grate/Utility Hazard?	N/A
	Obstruction Type			Storm Grate/Utility Type	
		N/A			N/A
			Yes	Surface Condition? (G/P)	Good
			N/A	Curb Slope (%)	3.3

**Remove & Replace Entire Ramp.**
