Access Compliance Report

Public Rights-of-Way

(Curb Ramps)

Intersection ID: 53289	Main Street: PROSPERITY RIDGE RD	Cross Street: PROSPERITY RIDGE RD	Location: E
ADA ID: 4A7D01E0E773	Ramp Type: Perp	Initial Pass/Fail: Fail	Overall Compliance: No
Codes/Mitigation Info/Possible Solution		Field Measurements/Component Compliance	
Severity Score: 8.75

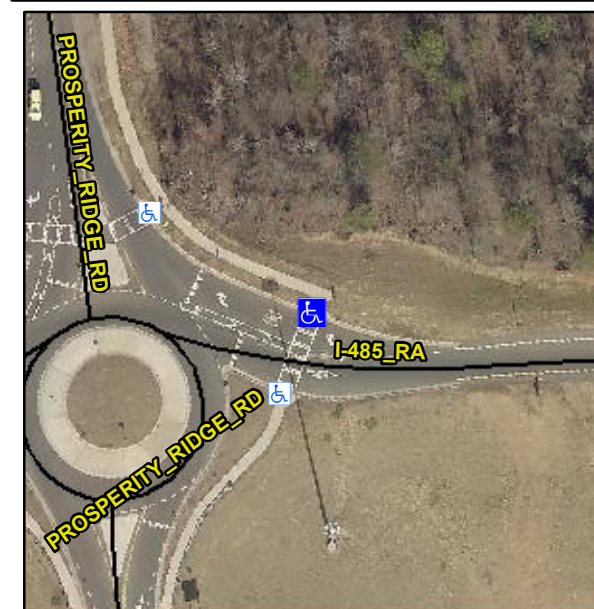
Compliance	Description	Data	Compliance	Description	Data
N/A	Ramp Length (in)	88.5	Yes	Ramp Slope (%)	5.5
No	Ramp Width (in)	47.0	Yes	Ramp XSlope (%)	1.8
N/A	Flare Type LT	N/A	N/A	Flare Type RT	N/A
N/A	Flare Slope LT (%)	N/A	N/A	Flare Slope RT (%)	N/A
N/A	Flare Traversable LT?	N/A	N/A	Flare Traversable RT?	N/A
N/A	Landing Length (in)	N/A	N/A	DWS Provided?	N/A
N/A	Landing Width (in)	N/A	N/A	DWS Contrast?	N/A
N/A	Landing Slope (%)	N/A	N/A	DWS Length (in)	N/A
N/A	Landing X Slope (%)	N/A	N/A	DWS Full Width?	N/A
N/A	Landing Curb? (Y/N)	N/A	N/A	DWS Offset (in)	N/A
N/A	Shared Landing?	N/A			
N/A	Gutter Ponding?	N/A	N/A	Gutter Slope (%)	N/A
N/A	Gutter Lip Ht (in)	N/A	N/A	Gutter X Slope (%)	N/A
N/A	Painted X Walk1?	Yes	N/A	Painted X Walk2?	N/A
	X Walk 1 Direction	To S		X Walk 2 Direction	N/A
N/A	X Walk 1 Width (in)	104.0	N/A	X Walk 2 Width (in)	N/A
	X Walk 1 Slope (%)	0.6		X Walk 2 Slope (%)	N/A
	X Walk 1 X Slope (%)	2.9		X Walk 2 X Slope (%)	N/A

N/A	Ramp inside XWalk1?	Yes	N/A	Ramp inside XWalk2?	N/A
	Road Slope (%)	N/A	N/A	Clear Space?	N/A
	Road X Slope (%)	N/A	N/A	Clear Space to XWalk (in)	N/A
N/A	Any Obstructions?	N/A	N/A	Storm Grate/Utility Hazard?	N/A
	Obstruction Type			Storm Grate/Utility Type	
		N/A			N/A
			Yes	Surface Condition? (G/P)	Good

Remove & Replace Entire Ramp.

R304.5.1
