Access Compliance Report

Public Rights-of-Way

(Curb Ramps)

Intersection ID: 19749	Main Street: INGLESIDE_DR	Cross Street: KEELING_PL	Location: NE
ADA ID: 4A80CE5A8E69	Ramp Type: Directional1	Initial Pass/Fail: Fail	Overall Compliance: No
		Severity Score: 1.25

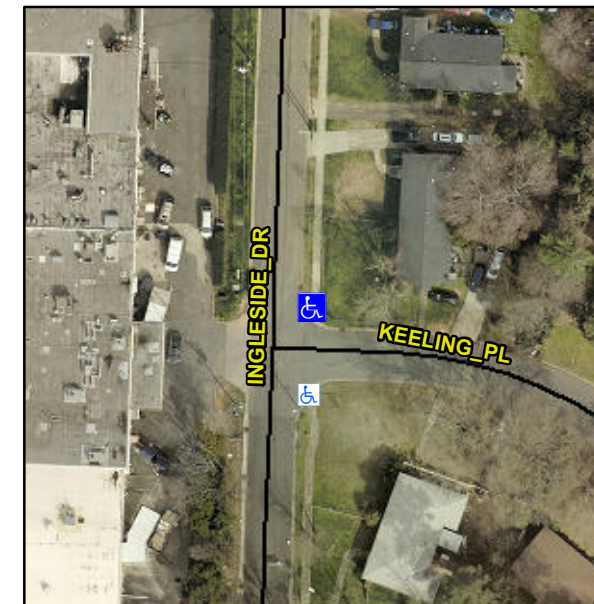
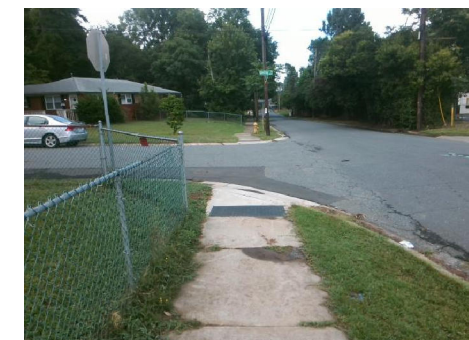
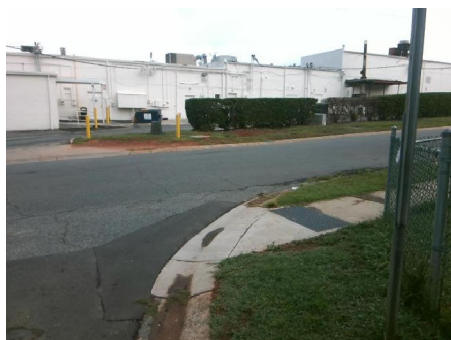
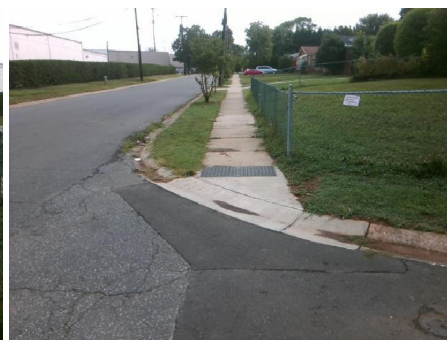
R304.5.3

Compliance	Description	Data	Compliance	Description	Data
N/A	Ramp Length (in)	73.0	N/A	Grade Break?	N/A
Yes	Ramp Width (in)	56.0	N/A	Grade Break Slope (%)	0.0
Yes	Ramp Slope (%)	2.5	N/A	Grade Break XSlope (%)	0.0
No	Ramp XSlope (%)	3.5			
N/A	Flare Type LT	N/A	N/A	Flare Type RT	N/A
N/A	Flare Slope LT (%)	N/A	N/A	Flare Slope RT (%)	0.0
N/A	Flare Traversable LT?	N/A	N/A	Flare Traversable RT?	N/A
N/A	Landing Length (in)	0.0	N/A	DWS Provided?	N/A
N/A	Landing Width (in)	0.0	N/A	DWS Contrast?	N/A
N/A	Landing Slope (%)	0.0	N/A	DWS Length (in)	N/A
N/A	Landing X Slope (%)	0.0	N/A	DWS Full Width?	N/A
N/A	Landing Curb? (Y/N)	N/A	N/A	DWS Offset LT (in)	N/A
N/A	Shared Landing?	N/A	N/A	DWS Offset RT (in)	N/A
N/A	Gutter Ponding?	0.0	N/A	Gutter Slope (%)	N/A
N/A	Gutter Lip Ht (in)	0.0	N/A	Gutter X Slope (%)	N/A
N/A	Painted X Walk1?	No		Road Slope (%)	0.2
	X Walk 1 Direction	To SE		Road X Slope (%)	3.1
	X Walk 1 Width (in)	N/A		Clear Space?	N/A

X Walk 1 Slope (%)	0.2	N/A	Clear Space to XWalk (in)	N/A
	X Walk 1 X Slope (%)	3.1	N/A	Storm Grate/Utility Hazard?	N/A
N/A	Ramp inside XWalk1?	N/A		Storm Grate/Utility Type	
N/A	Any Obstructions?	N/A			N/A
	Obstruction Type		Yes	Surface Condition? (G/P)	Good
			N/A	Curb Slope (%)	16.9

Possible Solutions:

Remove & Replace Entire Ramp.

Total Cost: \$ 1600.00
