Access Compliance Report

Public Rights-of-Way

(Curb Ramps)

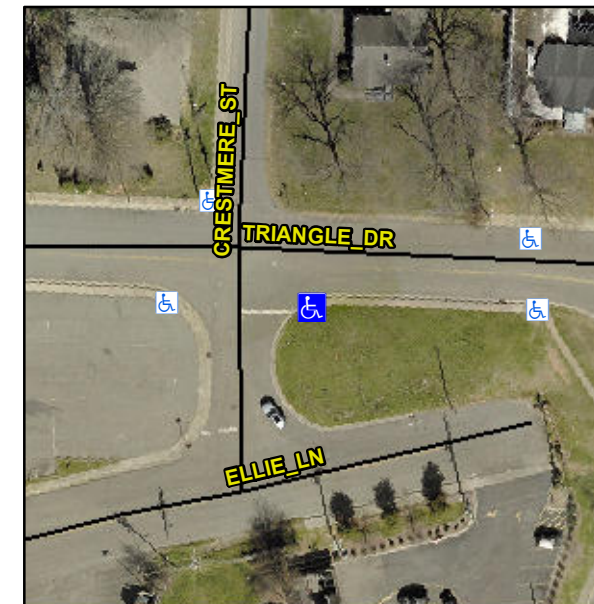
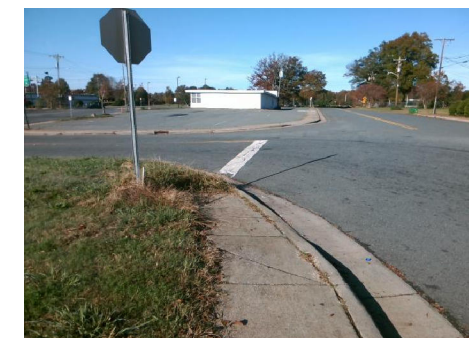
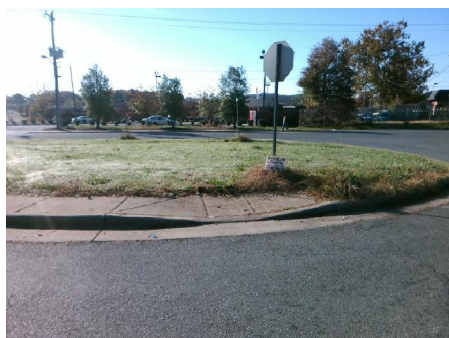
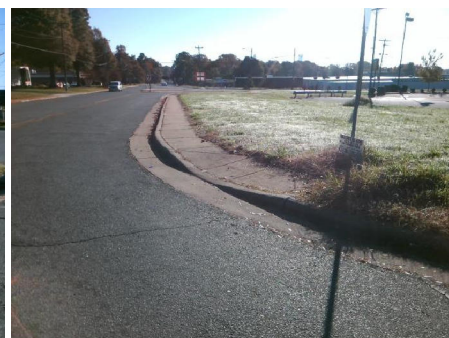
Intersection ID: 9903	Main Street: CRESTMERE_ST	Cross Street: TRIANGLE_DR	Location:	E
ADA ID: 4A84212BBB16	Ramp Type: Perp	Initial Pass/Fail: Fail	Overall Compliance: No	Severity Score: 47.5
Codes/Mitigation Info/Possible Solution		Field Measurements/Component Compliance

Not Found, R304.5.1, R304.2.2

Compliance	Description	Data	Compliance	Description	Data
N/A	Ramp Length (in)	48.0	No	Ramp Slope (%)	9.9
No	Ramp Width (in)	30.5	Yes	Ramp XSlope (%)	0.5
N/A	Flare Type LT	N/A	N/A	Flare Type RT	N/A
N/A	Flare Slope LT (%)	N/A	N/A	Flare Slope RT (%)	N/A
N/A	Flare Traversable LT?	N/A	N/A	Flare Traversable RT?	N/A
N/A	Landing Length (in)	N/A	N/A	DWS Provided?	N/A
N/A	Landing Width (in)	N/A	N/A	DWS Contrast?	N/A
N/A	Landing Slope (%)	N/A	N/A	DWS Length (in)	N/A
N/A	Landing X Slope (%)	N/A	N/A	DWS Full Width?	N/A
N/A	Landing Curb? (Y/N)	N/A	N/A	DWS Offset (in)	N/A
N/A	Shared Landing?	N/A			
N/A	Gutter Ponding?	N/A	N/A	Gutter Slope (%)	N/A
N/A	Gutter Lip Ht (in)	N/A	N/A	Gutter X Slope (%)	N/A
N/A	Painted X Walk1?	No	N/A	Painted X Walk2?	N/A
	X Walk 1 Direction	To W		X Walk 2 Direction	N/A
N/A	X Walk 1 Width (in)	N/A	N/A	X Walk 2 Width (in)	N/A
	X Walk 1 Slope (%)	2.9		X Walk 2 Slope (%)	N/A
	X Walk 1 X Slope (%)	5.6		X Walk 2 X Slope (%)	N/A

N/A	Ramp inside XWalk1?	N/A	N/A	Ramp inside XWalk2?	N/A
	Road Slope (%)	N/A	N/A	Clear Space?	N/A
	Road X Slope (%)	N/A	N/A	Clear Space to XWalk (in)	N/A
N/A	Any Obstructions?	N/A	N/A	Storm Grate/Utility Hazard?	N/A
	Obstruction Type			Storm Grate/Utility Type	
		N/A			N/A
			Yes	Surface Condition? (G/P)	Good

Remove & Replace Entire Ramp.
