Access Compliance Report

Public Rights-of-Way

(Curb Ramps)

Intersection ID: 13019	Main Street: E_STONEWALL_ST	Cross Street: S_BREVARD_ST	Location: NW
ADA ID: 4A8BAB3CB4D7	Ramp Type: Directional1	Initial Pass/Fail: Pass	Overall Compliance: Yes
Severity Score: 0			
Codes/Mitigation Info/Possible Solution		Field Measurements/Component Compliance

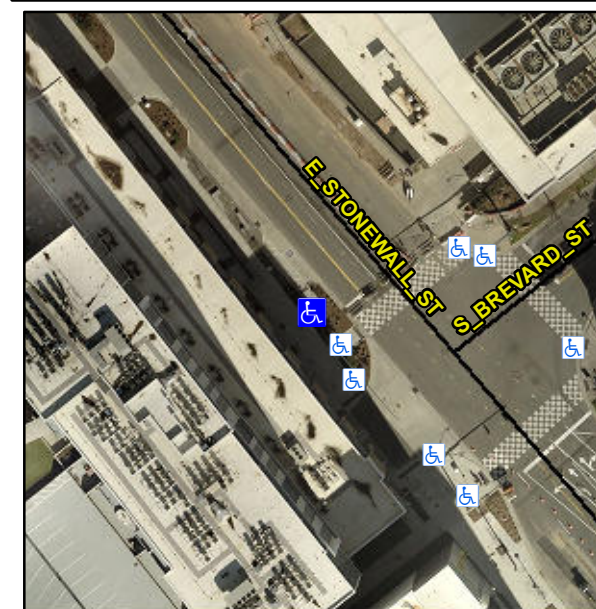
ACCESS AISLE RAMP

Compliance	Description	Data	Compliance	Description	Data
N/A	Ramp Length (in)	72.0	Yes	Grade Break?	Yes
Yes	Ramp Width (in)	57.0	Yes	Grade Break Slope (%)	0.4
Yes	Ramp Slope (%)	4.7	Yes	Grade Break XSlope (%)	0.2
Yes	Ramp XSlope (%)	1.2			
Yes	Flare Type LT	N/A	Yes	Flare Type RT	N/A
N/A	Flare Slope LT (%)	N/A	N/A	Flare Slope RT (%)	N/A
N/A	Flare Traversable LT?	No	N/A	Flare Traversable RT?	No
Yes	Landing Length (in)	59.0	Yes	DWS Provided?	Yes
Yes	Landing Width (in)	57.0	Yes	DWS Contrast?	Yes
Yes	Landing Slope (%)	1.1	Yes	DWS Length (in)	24.0
Yes	Landing X Slope (%)	0.8	Yes	DWS Full Width?	Yes
N/A	Landing Curb? (Y/N)	N/A	Yes	DWS Offset LT (in)	5.0
N/A	Shared Landing?	No	Yes	DWS Offset RT (in)	2.0
Yes	Gutter Ponding?	No	Yes	Gutter Slope (%)	0.7
Yes	Gutter Lip Ht (in)	0.0	Yes	Gutter X Slope (%)	0.7
N/A	Painted X Walk1?	No		Road Slope (%)	N/A
	X Walk 1 Direction	To NW		Road X Slope (%)	N/A
	X Walk 1 Width (in)	N/A		Clear Space?	Yes

X Walk 1 Slope (%)	N/A	N/A	Clear Space to XWalk (in)	N/A
	X Walk 1 X Slope (%)	N/A	Yes	Storm Grate/Utility Hazard?	No
N/A	Ramp inside XWalk1?	N/A		Storm Grate/Utility Type	
Yes	Any Obstructions?	No			N/A
	Obstruction Type		Yes	Surface Condition? (G/P)	Good
			N/A	Curb Slope (%)	3.0

N/A
