Access Compliance Report

Public Rights-of-Way

(Curb Ramps)

Intersection ID: 44421	Main Street: CENTRAL_AV	Cross Street: N/A	Location: S
ADA ID: 4A8DD0A9E085	Ramp Type: Perp	Initial Pass/Fail: Fail	Overall Compliance: No
Codes/Mitigation Info/Possible Solution		Field Measurements/Component Compliance	
Severity Score: 12.5

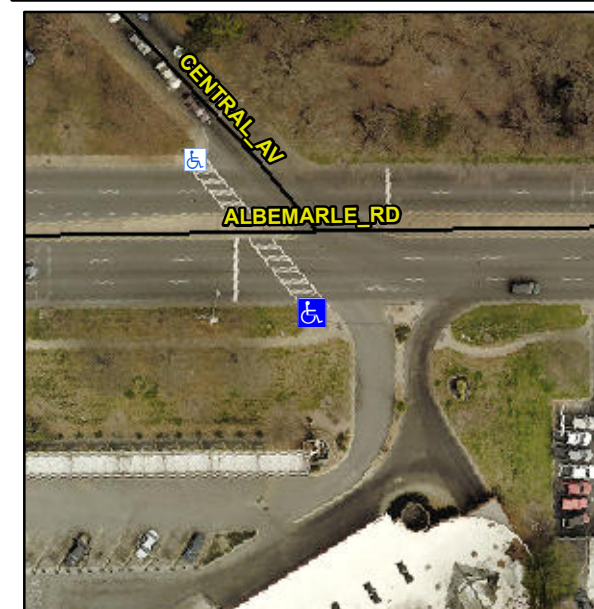
PROW/ADA:

Not Found, R304.2.2

Compliance	Description	Data	Compliance	Description	Data
N/A	Ramp Length (in)	71.5	No	Ramp Slope (%)	9.3
Yes	Ramp Width (in)	48.0	Yes	Ramp XSlope (%)	0.3
N/A	Flare Type LT	N/A	N/A	Flare Type RT	N/A
N/A	Flare Slope LT (%)	N/A	N/A	Flare Slope RT (%)	N/A
N/A	Flare Traversable LT?	N/A	N/A	Flare Traversable RT?	N/A
N/A	Landing Length (in)	N/A	N/A	DWS Provided?	N/A
N/A	Landing Width (in)	N/A	N/A	DWS Contrast?	N/A
N/A	Landing Slope (%)	N/A	N/A	DWS Length (in)	N/A
N/A	Landing X Slope (%)	N/A	N/A	DWS Full Width?	N/A
N/A	Landing Curb? (Y/N)	N/A	N/A	DWS Offset (in)	N/A
N/A	Shared Landing?	N/A			
N/A	Gutter Ponding?	N/A	N/A	Gutter Slope (%)	N/A
N/A	Gutter Lip Ht (in)	N/A	N/A	Gutter X Slope (%)	N/A
N/A	Painted X Walk1?	Yes	N/A	Painted X Walk2?	N/A
	X Walk 1 Direction	To NW		X Walk 2 Direction	N/A
N/A	X Walk 1 Width (in)	108.0	N/A	X Walk 2 Width (in)	N/A
	X Walk 1 Slope (%)	3.0		X Walk 2 Slope (%)	N/A
	X Walk 1 X Slope (%)	1.4		X Walk 2 X Slope (%)	N/A

N/A	Ramp inside XWalk1?	Yes	N/A	Ramp inside XWalk2?	N/A
	Road Slope (%)	N/A	N/A	Clear Space?	N/A
	Road X Slope (%)	N/A	N/A	Clear Space to XWalk (in)	N/A
N/A	Any Obstructions?	N/A	N/A	Storm Grate/Utility Hazard?	N/A
	Obstruction Type			Storm Grate/Utility Type	
		N/A			N/A
			Yes	Surface Condition? (G/P)	Good

Possible Solutions:

Remove & Replace Entire Ramp.
