## **Access Compliance Report Public Rights-of-Way** (Curb Ramps)

Intersection ID: 15856 Main Street: PARK RD Cross Street: SALEM DR Location: NE **Overall Compliance: No Severity Score: ADA ID: 4A8F450CDF33** Ramp Type: PerpDiag Initial Pass/Fail: Fail 37.5

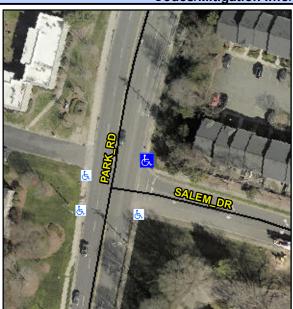
No N/A Ramp Length (in) 48.0 Ramp Slope (%) No Yes Ramp Width (in) 48.0 Ramp XSlope (%) N/A N/A Flare Type LT N/A Flare Type RT N/A N/A Flare Slope RT (%) Flare Slope LT (%) N/A N/A Flare Traversable LT? N/A N/A Flare Traversable RT? N/A N/A N/A **DWS Provided?** Landing Length (in) N/A Landing Width (in) N/A N/A **DWS Contrast?** N/A N/A Landing Slope (%) N/A DWS Length (in) N/A Landing X Slope (%) N/A N/A DWS Full Width? N/A Landing Curb? (Y/N) N/A N/A DWS Offset (in) N/A N/A Shared Landing? N/A **Gutter Ponding?** N/A N/A Gutter Slope (%) N/A Gutter Lip Ht (in) N/A N/A Gutter X Slope (%) N/A Painted X Walk1? No N/A Painted X Walk2? X Walk 1 Direction To W X Walk 2 Direction N/A N/A X Walk 1 Width (in) N/A X Walk 2 Width (in) X Walk 1 Slope (%) 9.8 X Walk 2 Slope (%) X Walk 1 X Slope (%) 5.4 X Walk 2 X Slope (%) N/A N/A N/A Ramp inside XWalk2? Ramp inside XWalk1? Road Slope (%) 2.6 N/A Clear Space? N/A Road X Slope (%) 8.5 Clear Space to XWalk (in) N/A N/A Any Obstructions? N/A Storm Grate/Utility Hazard? **Obstruction Type** Storm Grate/Utility Type

Street 1 Name **PARK RD** Stop Condition-Street 2 None **SALEM DR** Street 2 Name Stop Condition-Street 1 StopSign Possible Solutions: Remove & Replace Curb Ramp With Two New Directional Ramps or Equivalent. Restripe Crosswalk. Surveyor Notes: N/A PROW/ADA: Not Found, R304.2.2, R304.5.3
