Access Compliance Report

Public Rights-of-Way

(Curb Ramps)

Intersection ID: 10292	Main Street: BEATTIES_FORD_RD	Cross Street: DIXON_ST	Location: SW
ADA ID: 4A8FBF9312C1	Ramp Type: PerpDiag	Initial Pass/Fail: Fail	Overall Compliance: No
Codes/Mitigation Info/Possible Solution		Field Measurements/Component Compliance	
Severity Score: 12.5

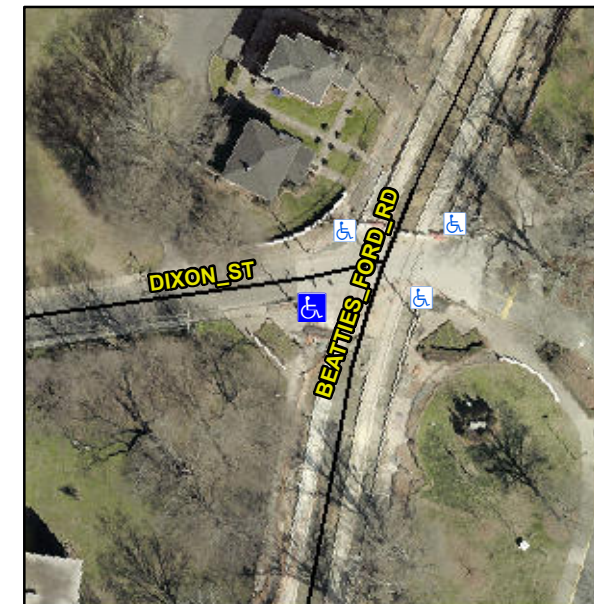
Compliance	Description	Data	Compliance	Description	Data
N/A	Ramp Length (in)	63.0	No	Ramp Slope (%)	11.4
Yes	Ramp Width (in)	64.0	Yes	Ramp XSlope (%)	1.2
N/A	Flare Type LT	N/A	N/A	Flare Type RT	N/A
N/A	Flare Slope LT (%)	N/A	N/A	Flare Slope RT (%)	N/A
N/A	Flare Traversable LT?	N/A	N/A	Flare Traversable RT?	N/A
N/A	Landing Length (in)	N/A	N/A	DWS Provided?	N/A
N/A	Landing Width (in)	N/A	N/A	DWS Contrast?	N/A
N/A	Landing Slope (%)	N/A	N/A	DWS Length (in)	N/A
N/A	Landing X Slope (%)	N/A	N/A	DWS Full Width?	N/A
N/A	Landing Curb? (Y/N)	N/A	N/A	DWS Offset (in)	N/A
N/A	Shared Landing?	N/A			
N/A	Gutter Ponding?	Yes	N/A	Gutter Slope (%)	N/A
N/A	Gutter Lip Ht (in)	N/A	N/A	Gutter X Slope (%)	N/A
N/A	Painted X Walk1?	Yes	N/A	Painted X Walk2?	Yes
	X Walk 1 Direction	To E		X Walk 2 Direction	To NE
N/A	X Walk 1 Width (in)	98.0	N/A	X Walk 2 Width (in)	101.0
	X Walk 1 Slope (%)	7.0		X Walk 2 Slope (%)	2.9
	X Walk 1 X Slope (%)	1.9		X Walk 2 X Slope (%)	3.2

N/A	Ramp inside XWalk1?	Yes	N/A	Ramp inside XWalk2?	Yes
	Road Slope (%)	1.8	N/A	Clear Space?	N/A
	Road X Slope (%)	7.1	N/A	Clear Space to XWalk (in)	N/A
N/A	Any Obstructions?	N/A	N/A	Storm Grate/Utility Hazard?	N/A
	Obstruction Type			Storm Grate/Utility Type	
		N/A			N/A
		Yes		Surface Condition? (G/P)	Good

Possible Solutions:

Remove & Replace Curb Ramp With Two New Directional Ramps or Equivalent.
