# Access Compliance Report

## Public Rights-of-Way

### (Curb Ramps)

Intersection ID: 15470	Main Street: AMITY_SPRINGS_DR	Cross Street: THORN_GROVE_LN	Location:	N
ADA ID: 4A90FE77307E	Ramp Type: Perp	Initial Pass/Fail: Fail	Overall Compliance: No	Severity Score: 23.75
Codes/Mitigation Info/Possible Solution		Field Measurements/Component Compliance

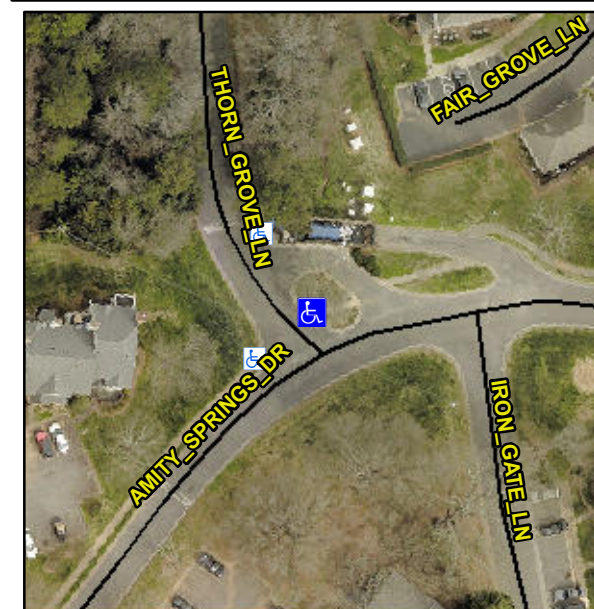
**Not Found, R304.5.1, R302.7**

Compliance	Description	Data	Compliance	Description	Data
N/A	Ramp Length (in)	44.0	Yes	Ramp Slope (%)	7.4
No	Ramp Width (in)	46.5	Yes	Ramp XSlope (%)	1.5
N/A	Flare Type LT	N/A	N/A	Flare Type RT	N/A
N/A	Flare Slope LT (%)	N/A	N/A	Flare Slope RT (%)	N/A
N/A	Flare Traversable LT?	N/A	N/A	Flare Traversable RT?	N/A
N/A	Landing Length (in)	N/A	N/A	DWS Provided?	N/A
N/A	Landing Width (in)	N/A	N/A	DWS Contrast?	N/A
N/A	Landing Slope (%)	N/A	N/A	DWS Length (in)	N/A
N/A	Landing X Slope (%)	N/A	N/A	DWS Full Width?	N/A
N/A	Landing Curb? (Y/N)	N/A	N/A	DWS Offset (in)	N/A
N/A	Shared Landing?	N/A			
N/A	Gutter Ponding?	N/A	N/A	Gutter Slope (%)	N/A
N/A	Gutter Lip Ht (in)	N/A	N/A	Gutter X Slope (%)	N/A
N/A	Painted X Walk1?	No	N/A	Painted X Walk2?	N/A
	X Walk 1 Direction	To SW		X Walk 2 Direction	N/A
N/A	X Walk 1 Width (in)	N/A	N/A	X Walk 2 Width (in)	N/A
	X Walk 1 Slope (%)	0.8		X Walk 2 Slope (%)	N/A
	X Walk 1 X Slope (%)	0.9		X Walk 2 X Slope (%)	N/A

N/A	Ramp inside XWalk1?	N/A	N/A	Ramp inside XWalk2?	N/A
	Road Slope (%)	N/A	N/A	Clear Space?	N/A
	Road X Slope (%)	N/A	N/A	Clear Space to XWalk (in)	N/A
N/A	Any Obstructions?	N/A	N/A	Storm Grate/Utility Hazard?	N/A
	Obstruction Type			Storm Grate/Utility Type	
		N/A			N/A
		No		Surface Condition? (G/P)	Poor

**Remove & Replace Entire Ramp.**

Total Cost: \$ 1850.00
