# Access Compliance Report

## Public Rights-of-Way

### (Curb Ramps)

| Intersection ID: 53971 | Main Street: BEREWICK_TOWN_CENTRE | Cross Street: CADEN_RD | Location: W |

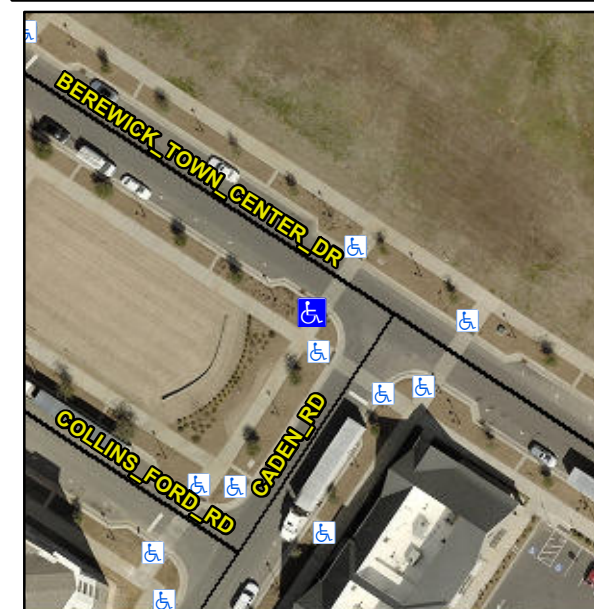
**Not Found, R304.5.3, R305.2**

| Compliance | Description | Data | Compliance | Description | Data |
|---|---|---|---|---|---|
| Yes | Ramp Width (in) | 97.0 | No | BlendTrans XSlope (%) | 2.2 |
| No | Landing X Slope (%) | 2.4 | Yes | DWS Full Width? | Yes |
| N/A | Landing Curb? (Y/N) | No | No | DWS Offset (in) | 6.0 |
| Yes | Gutter Lip Ht (in) | 0.0 | No | Gutter X Slope (%) | 2.2 |

**Remove & Replace Curb Ramp With Two New Directional Ramps or Equivalent. Remove & Replace Gutter.**
