Access Compliance Report

Public Rights-of-Way

(Curb Ramps)

Intersection ID: 12879	Main Street: HICKORY GROVE RD	Cross Street: N SHARON AMITY RD	Location: S
ADA ID: 4AA2144810C0	Ramp Type: PerpDiag	Initial Pass/Fail: Fail	Overall Compliance: No
Severity Score: 8.75			
Codes/Mitigation Info/Possible Solution		Field Measurements/Component Compliance

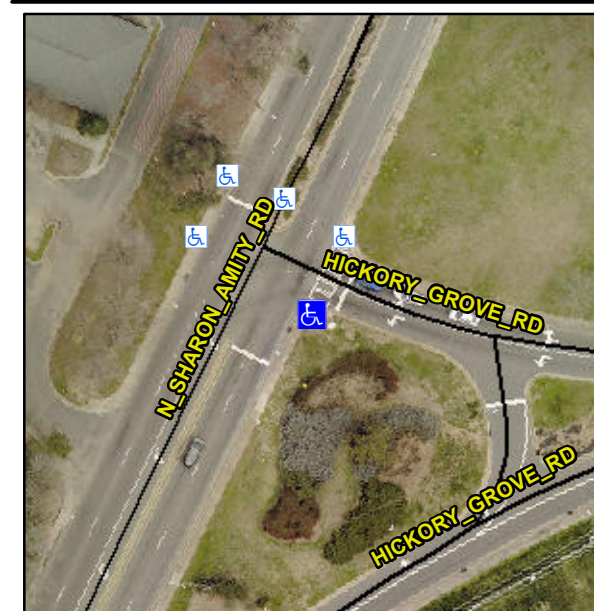
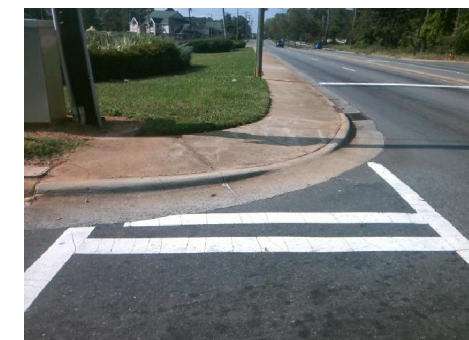
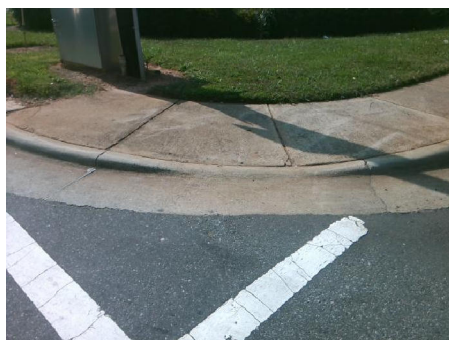
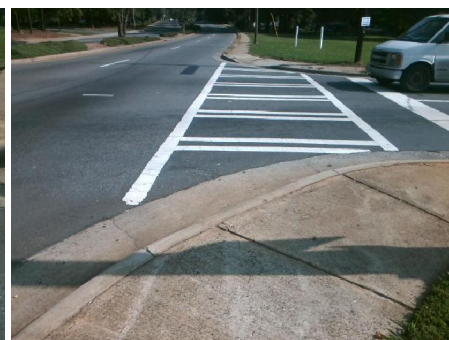
Not Found, R304.5.1

Compliance	Description	Data	Compliance	Description	Data
N/A	Ramp Length (in)	59.0	Yes	Ramp Slope (%)	7.5
No	Ramp Width (in)	42.0	Yes	Ramp XSlope (%)	1.0
N/A	Flare Type LT	N/A	N/A	Flare Type RT	N/A
N/A	Flare Slope LT (%)	N/A	N/A	Flare Slope RT (%)	N/A
N/A	Flare Traversable LT?	N/A	N/A	Flare Traversable RT?	N/A
N/A	Landing Length (in)	N/A	N/A	DWS Provided?	N/A
N/A	Landing Width (in)	N/A	N/A	DWS Contrast?	N/A
N/A	Landing Slope (%)	N/A	N/A	DWS Length (in)	N/A
N/A	Landing X Slope (%)	N/A	N/A	DWS Full Width?	N/A
N/A	Landing Curb? (Y/N)	N/A	N/A	DWS Offset (in)	N/A
N/A	Shared Landing?	N/A			
N/A	Gutter Ponding?	N/A	N/A	Gutter Slope (%)	N/A
N/A	Gutter Lip Ht (in)	N/A	N/A	Gutter X Slope (%)	N/A
N/A	Painted X Walk1?	Yes	N/A	Painted X Walk2?	No
	X Walk 1 Direction	To NE		X Walk 2 Direction	To NW
N/A	X Walk 1 Width (in)	112.0	N/A	X Walk 2 Width (in)	N/A
	X Walk 1 Slope (%)	0.2		X Walk 2 Slope (%)	2.1
	X Walk 1 X Slope (%)	1.7		X Walk 2 X Slope (%)	2.1

N/A	Ramp inside XWalk1?	Yes	N/A	Ramp inside XWalk2?	N/A
	Road Slope (%)	1.7	N/A	Clear Space?	N/A
	Road X Slope (%)	1.2	N/A	Clear Space to XWalk (in)	N/A
N/A	Any Obstructions?	N/A	N/A	Storm Grate/Utility Hazard?	N/A
	Obstruction Type			Storm Grate/Utility Type	
		N/A			N/A
		Yes		Surface Condition? (G/P)	Good

Remove & Replace Curb Ramp With Two New Directional Ramps or Equivalent.

Total Cost: \$ 3200.00
