Access Compliance Report Public Rights-of-Way (Curb Ramps)

Intersection ID: 27979 Main Street: PROVIDENCE RD WEST **Cross Street: MARVIN RD** SW Location: **Overall Compliance: No Severity Score:** ADA ID: 4ABCCAB5F346 Ramp Type: BlendTrans1 Initial Pass/Fail: Fail 8.75

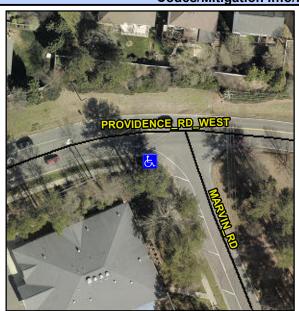
Compliance Description Data Compliance Description Data Yes BlendTrans Slope (%) N/A Ramp Length (in) 94.0 0.4 Yes No Ramp Width (in) 44.0 BlendTrans XSlope (%) 0.5 N/A N/A Flare Type LT N/A Flare Type RT N/A N/A Flare Slope LT (%) N/A N/A Flare Slope RT (%) N/A N/A Flare Traversable LT? N/A N/A Flare Traversable RT? N/A N/A Landing Length (in) N/A N/A **DWS Provided?** N/A N/A Landing Width (in) N/A N/A **DWS Contrast?** N/A N/A N/A N/A Landing Slope (%) DWS Length (in) N/A N/A Landing X Slope (%) N/A N/A DWS Full Width? N/A N/A Landing Curb? (Y/N) N/A N/A DWS Offset (in) N/A N/A N/A Shared Landing? N/A **Gutter Ponding?** N/A N/A Gutter Slope (%) N/A N/A Gutter Lip Ht (in) N/A N/A Gutter X Slope (%) N/A N/A Painted X Walk1? No N/A Painted X Walk2? No X Walk 1 Direction To E X Walk 2 Direction To N N/A X Walk 1 Width (in) X Walk 2 Width (in) N/A X Walk 1 Slope (%) 2.5 X Walk 2 Slope (%) 8.6 X Walk 1 X Slope (%) 9.6 X Walk 2 X Slope (%) 0.6 N/A N/A Ramp inside XWalk2? N/A N/A Ramp inside XWalk1? Road Slope (%) 1.3 Clear Space? N/A Road X Slope (%) N/A Clear Space to XWalk (in) N/A 9.0 N/A N/A Any Obstructions? N/A Storm Grate/Utility Hazard? N/A **Obstruction Type** Storm Grate/Utility Type N/A N/A Yes Surface Condition? (G/P) Good No 5.2

MARVIN RD Street 1 Name Stop Condition-Street 1 StopSign PROVIDENCE RD WEST Street 2 Name Stop Condition-Street 2 None Possible Solutions: Remove & Replace Curb Ramp With Two New Directional Ramps or Equivalent. Surveyor Notes: N/A PROW/ADA: Not Found, R304.5.1
