# Access Compliance Report

## Public Rights-of-Way

### (Curb Ramps)

Intersection ID: 14178	Main Street: E_8TH_ST	Cross Street: RIDGEWAY_AV	Location: NE
ADA ID: 4AD1AF98B942	Ramp Type: Perp	Initial Pass/Fail: Fail	Overall Compliance: No
		Severity Score: 25

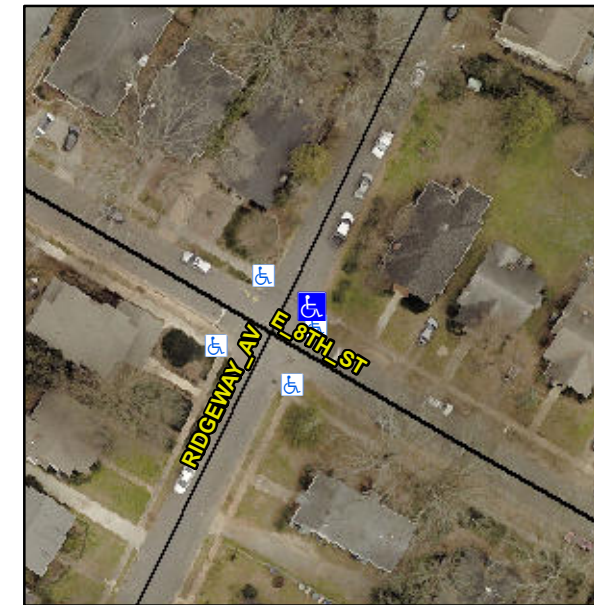
**R304.2.2, R304.5.3**

Compliance	Description	Data	Compliance	Description	Data
N/A	Ramp Length (in)	53.0	No	Ramp Slope (%)	8.9
Yes	Ramp Width (in)	48.0	No	Ramp XSlope (%)	5.2
N/A	Flare Type LT	N/A	N/A	Flare Type RT	N/A
N/A	Flare Slope LT (%)	N/A	N/A	Flare Slope RT (%)	N/A
N/A	Flare Traversable LT?	N/A	N/A	Flare Traversable RT?	N/A
N/A	Landing Length (in)	N/A	N/A	DWS Provided?	N/A
N/A	Landing Width (in)	N/A	N/A	DWS Contrast?	N/A
N/A	Landing Slope (%)	N/A	N/A	DWS Length (in)	N/A
N/A	Landing X Slope (%)	N/A	N/A	DWS Full Width?	N/A
N/A	Landing Curb? (Y/N)	N/A	N/A	DWS Offset (in)	N/A
N/A	Shared Landing?	N/A			
N/A	Gutter Ponding?	N/A	N/A	Gutter Slope (%)	N/A
N/A	Gutter Lip Ht (in)	N/A	N/A	Gutter X Slope (%)	N/A
N/A	Painted X Walk1?	No	N/A	Painted X Walk2?	N/A
	X Walk 1 Direction	To NW		X Walk 2 Direction	N/A
N/A	X Walk 1 Width (in)	N/A	N/A	X Walk 2 Width (in)	N/A
	X Walk 1 Slope (%)	3.4		X Walk 2 Slope (%)	N/A
	X Walk 1 X Slope (%)	4.8		X Walk 2 X Slope (%)	N/A

N/A	Ramp inside XWalk1?	N/A	N/A	Ramp inside XWalk2?	N/A
	Road Slope (%)	N/A	N/A	Clear Space?	N/A
	Road X Slope (%)	N/A	N/A	Clear Space to XWalk (in)	N/A
N/A	Any Obstructions?	N/A	N/A	Storm Grate/Utility Hazard?	N/A
	Obstruction Type			Storm Grate/Utility Type	
		N/A			N/A
			Yes	Surface Condition? (G/P)	Good

**Remove & Replace Entire Ramp.**
