Intersection ID: 13611	Main Street: E_MOREHEAD_ST	Cross Street: EUCLID_AV	Location:	NW
ADA ID: 4AD907CE07FA	Ramp Type: PerpDiag	Initial Pass/Fail: Fail	Overall Compliance: No	Severity Score: 26.25

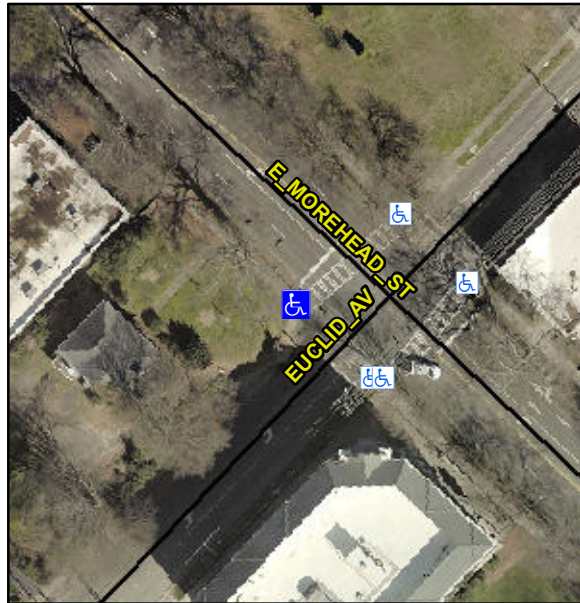
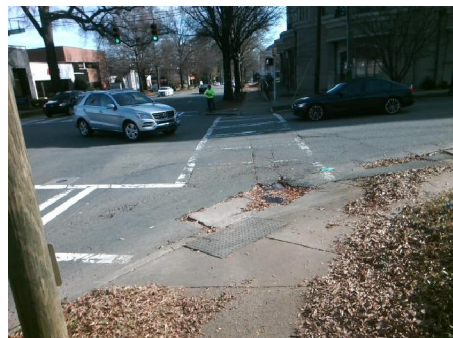
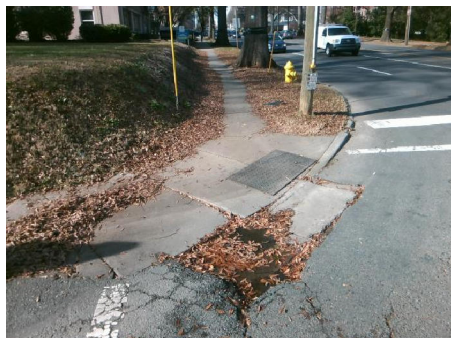
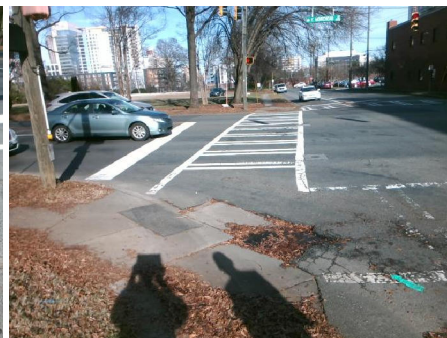
**Not Found, R304.2.2, R304.5.3**

Compliance	Description	Data	Compliance	Description	Data
N/A	Ramp Length (in)	57.0	No	Ramp Slope (%)	12.6
Yes	Ramp Width (in)	48.0	No	Ramp XSlope (%)	3.8
N/A	Flare Type LT	N/A	N/A	Flare Type RT	N/A
N/A	Flare Slope LT (%)	N/A	N/A	Flare Slope RT (%)	N/A
N/A	Flare Traversable LT?	N/A	N/A	Flare Traversable RT?	N/A
N/A	Landing Length (in)	N/A	N/A	DWS Provided?	N/A
N/A	Landing Width (in)	N/A	N/A	DWS Contrast?	N/A
N/A	Landing Slope (%)	N/A	N/A	DWS Length (in)	N/A
N/A	Landing X Slope (%)	N/A	N/A	DWS Full Width?	N/A
N/A	Landing Curb? (Y/N)	N/A	N/A	DWS Offset (in)	N/A
N/A	Shared Landing?	N/A			
N/A	Gutter Ponding?	N/A	N/A	Gutter Slope (%)	N/A
N/A	Gutter Lip Ht (in)	N/A	N/A	Gutter X Slope (%)	N/A
N/A	Painted X Walk1?	Yes	N/A	Painted X Walk2?	Yes
	X Walk 1 Direction	To SE		X Walk 2 Direction	To NE
N/A	X Walk 1 Width (in)	108.0	N/A	X Walk 2 Width (in)	104.0
	X Walk 1 Slope (%)	0.2		X Walk 2 Slope (%)	3.6
	X Walk 1 X Slope (%)	0.2		X Walk 2 X Slope (%)	1.2

N/A	Ramp inside XWalk1?	Yes	N/A	Ramp inside XWalk2?	Yes
	Road Slope (%)	3.7	N/A	Clear Space?	N/A
	Road X Slope (%)	3.3	N/A	Clear Space to XWalk (in)	N/A
N/A	Any Obstructions?	N/A	N/A	Storm Grate/Utility Hazard?	N/A
	Obstruction Type			Storm Grate/Utility Type	
		N/A			N/A
			Yes	Surface Condition? (G/P)	Good

**Remove & Replace Curb Ramp With Two New Directional Ramps or Equivalent.**
