Access Compliance Report

Public Rights-of-Way

(Curb Ramps)

| Intersection ID: 44471 | Main Street: COREY_COMMON_AV | Cross Street: REDDING_GLEN_AV | Location: SW |

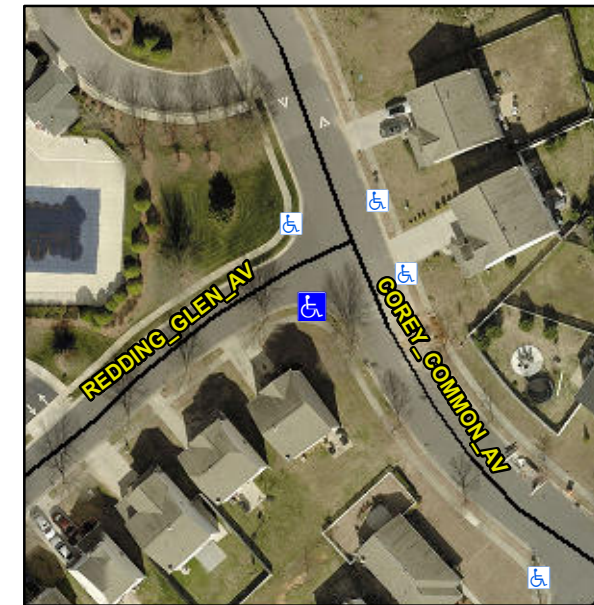
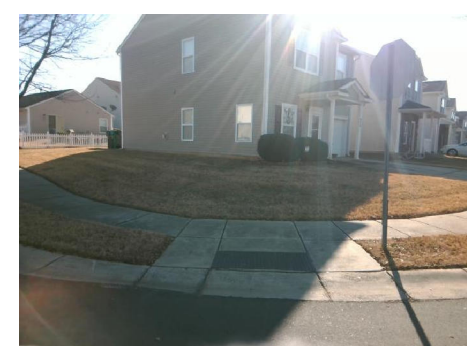
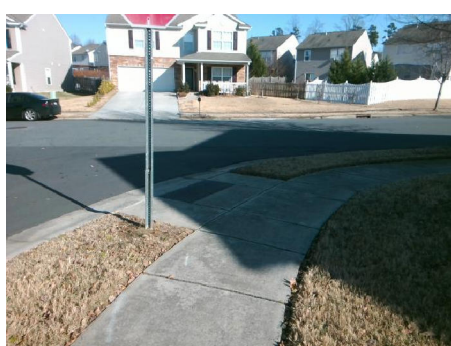
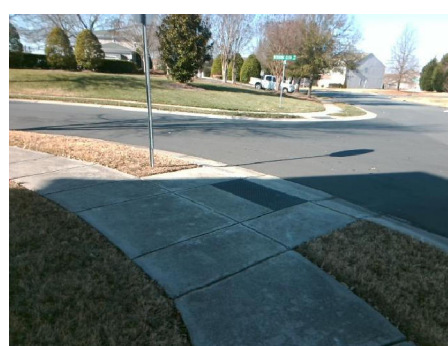
| ADA ID: 4AE5C275AB96 | Ramp Type: BlendTrans1 | Initial Pass/Fail: Fail | Overall Compliance: No |
| | | Severity Score: 8.75 | |

Not Found, R304.5.1

| Compliance | Description | Data | Compliance | Description | Data |
|---|---|---|---|---|---|
| No | Ramp Width (in) | 47.0 | Yes | BlendTrans XSlope (%) | 0.7 |
| | | | No | Curb Slope (%) | 8.8 |

Possible Solutions:

Remove & Replace Curb Ramp With Two New Directional Ramps or Equivalent.

Total Cost: \$ 3200.00
