## **Access Compliance Report Public Rights-of-Way** (Curb Ramps)

Intersection ID: 48166 Main Street: NORTHLAKE\_MALL\_DR Cross Street: NORTHLAKE\_CENTRE\_PY Location: NW Severity Score: 21.25 ADA ID: 4B076DA09737 Ramp Type: Perp Initial Pass/Fail: Fail **Overall Compliance: No**

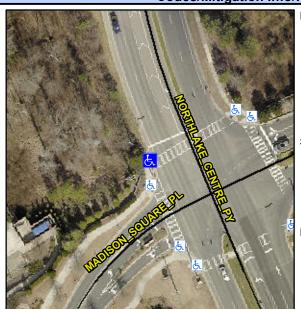
Field Measurements/Component Compliance							
	Compliance Description		Data	Compliance Description		Data	
	N/A	Ramp Length (in)	47.0	Yes	Ramp Slope (%)	6.3	
	No	Ramp Width (in)	47.0	No	Ramp XSlope (%)	5.2	
	N/A	Flare Type LT	N/A	N/A	Flare Type RT	N/A	
	N/A	Flare Slope LT (%)	N/A	N/A	Flare Slope RT (%)	N/A	
	N/A	Flare Traversable LT?	N/A	N/A	Flare Traversable RT?	N/A	
	N/A	Landing Length (in)	N/A	N/A	DWS Provided?	N/A	
	N/A	Landing Width (in)	N/A	N/A	DWS Contrast?	N/A	
	N/A	Landing Slope (%)	N/A	N/A	DWS Length (in)	N/A	
	N/A	Landing X Slope (%)	N/A	N/A	DWS Full Width?	N/A	
	N/A	Landing Curb? (Y/N)	N/A	N/A	DWS Offset (in)	N/A	
	N/A	Shared Landing?	N/A				
	N/A	Gutter Ponding?	N/A	N/A	Gutter Slope (%)	N/A	
	N/A	Gutter Lip Ht (in)	N/A	N/A	Gutter X Slope (%)	N/A	
	N/A	Painted X Walk1?	Yes	N/A	Painted X Walk2?	N/A	
		X Walk 1 Direction	To NE		X Walk 2 Direction	N/A	
	N/A	X Walk 1 Width (in)	115.0	N/A	X Walk 2 Width (in)	N/A

X Walk 1 Slope (%)	1.1		X Walk 2 Slope (%)	N/A	
		X Walk 1 X Slope (%)	3.7		X Walk 2 X Slope (%)	N/A	
	N/A	Ramp inside XWalk1?	Yes	N/A	Ramp inside XWalk2?	N/A	
		Road Slope (%)	N/A	N/A	Clear Space?	N/A	
		Road X Slope (%)	N/A	N/A	Clear Space to XWalk (in)	N/A	
	N/A	Any Obstructions?	N/A	N/A	Storm Grate/Utility Hazard?	N/A	
		Obstruction Type			Storm Grate/Utility Type		
			N/A			N/A	
				Yes	Surface Condition? (G/P)	Good

Possible Solutions:						
Remove & Replace Entire Ramp.						
Surveyor Notes:						
N/A						
PROW/ADA:						
Not Found, R304.5.1, R304.5.3
