# Access Compliance Report

## Public Rights-of-Way

### (Curb Ramps)

Intersection ID: 18210	Main Street: E_WOODLAWN_RD	Cross Street: BRANDYWINE_RD	Location: E
ADA ID: 4B0876DBE3C8	Ramp Type: BlendTrans2	Initial Pass/Fail: Fail	Overall Compliance: No
			Severity Score: 21.25

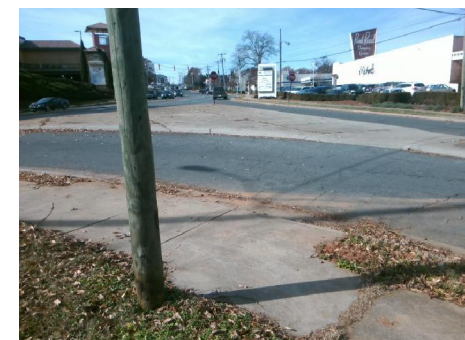
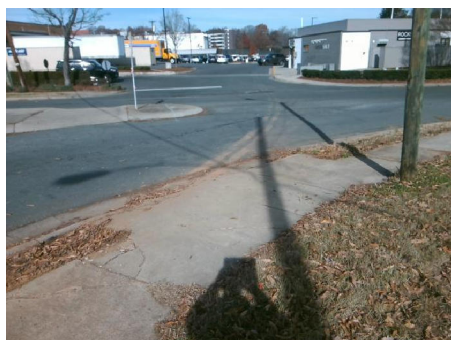
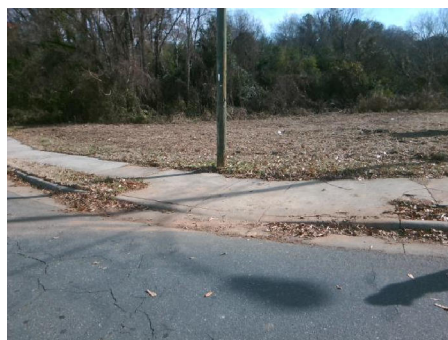
Possible Solutions:		Compliance	Description	Data	Compliance	Description	Data
	Remove & Replace Curb Ramp With Two New Directional Ramps or Equivalent.		N/A	Ramp Length (in)	78.0	Yes	BlendTrans Slope (%)	1.3
			No	Ramp Width (in)	43.0	No	BlendTrans XSlope (%)	6.8
			N/A	Flare Type LT	N/A	N/A	Flare Type RT	N/A
			N/A	Flare Slope LT (%)	N/A	N/A	Flare Slope RT (%)	N/A
			N/A	Flare Traversable LT?	N/A	N/A	Flare Traversable RT?	N/A
			N/A	Landing Length (in)	N/A	N/A	DWS Provided?	N/A
			N/A	Landing Width (in)	N/A	N/A	DWS Contrast?	N/A
			N/A	Landing Slope (%)	N/A	N/A	DWS Length (in)	N/A
			N/A	Landing X Slope (%)	N/A	N/A	DWS Full Width?	N/A
Surveyor Notes:			N/A	Landing Curb? (Y/N)	N/A	N/A	DWS Offset (in)	N/A
PROW/ADA:			N/A	Shared Landing?	N/A			
R304.5.1, R304.5.3			N/A	Gutter Ponding?	N/A	N/A	Gutter Slope (%)	N/A
			N/A	Gutter Lip Ht (in)	N/A	N/A	Gutter X Slope (%)	N/A

N/A	Painted X Walk1?	No	N/A	Painted X Walk2?	N/A
				X Walk 1 Direction	To NW		X Walk 2 Direction	N/A
				X Walk 1 Width (in)	N/A		X Walk 2 Width (in)	N/A
				X Walk 1 Slope (%)	2.1		X Walk 2 Slope (%)	N/A
				X Walk 1 X Slope (%)	4.1		X Walk 2 X Slope (%)	N/A
			N/A	Ramp inside XWalk1?	N/A	N/A	Ramp inside XWalk2?	N/A
				Road Slope (%)	4.1		Clear Space?	N/A
				Road X Slope (%)	2.1	N/A	Clear Space to XWalk (in)	N/A
			N/A	Any Obstructions?	N/A	N/A	Storm Grate/Utility Hazard?	N/A
				Obstruction Type			Storm Grate/Utility Type	
					N/A			N/A
						Yes	Surface Condition? (G/P)	Good
						N/A	Curb Slope (%)	N/A
